Bulletin Ref: TB23a

Renault Broken Wire

AAL1598

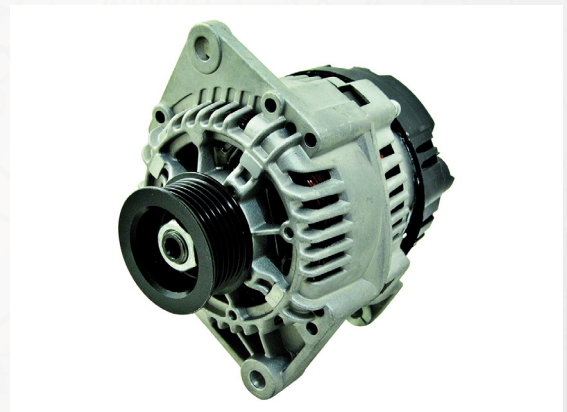
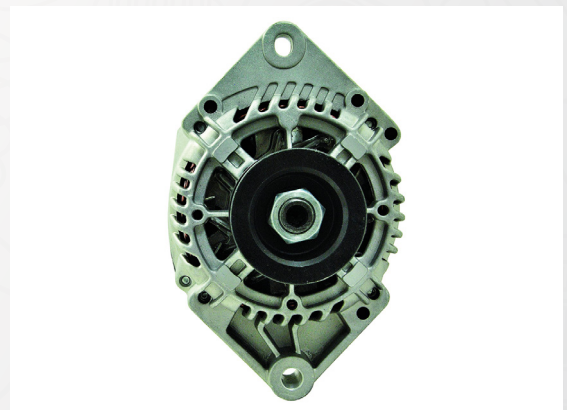
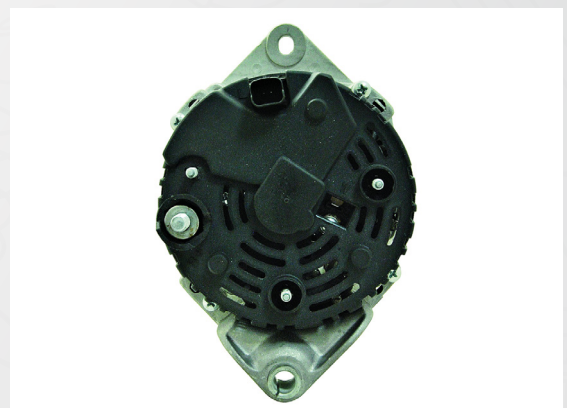
Poor or broken connections are common on these Renault models.

Trace the main feed from the plug to the wiring loom and check for broken wires or connections.
