TECHNICAL BULLETIN

NAL1431

Bulletin Ref: TB8n

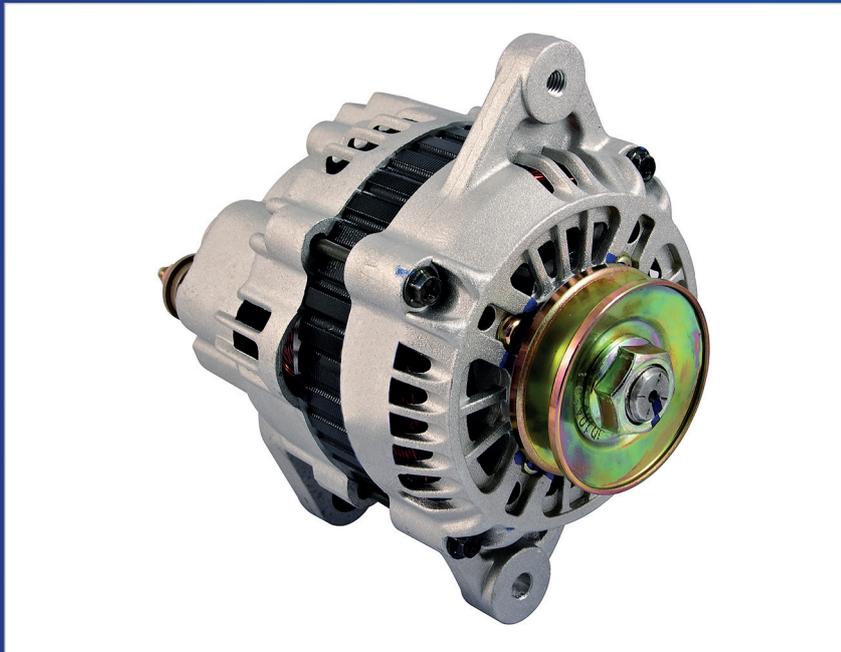
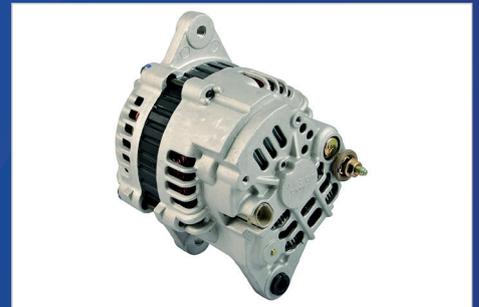
The main feed from the battery to alternator is prone to breaking, double check this is in good condition before ordering and fitting.
