Product Name: **BOV Kompact EM VR4**
Product Description: **BOV Kompact EM VR4 (MK5 Polo GTI)**
Product Number: TS-0223-1X91
Document Version: V1.00 Rev A
Patent #: AU-[2018253619](#) UK-[GB1817612.3](#) USA-[16/174413](#)

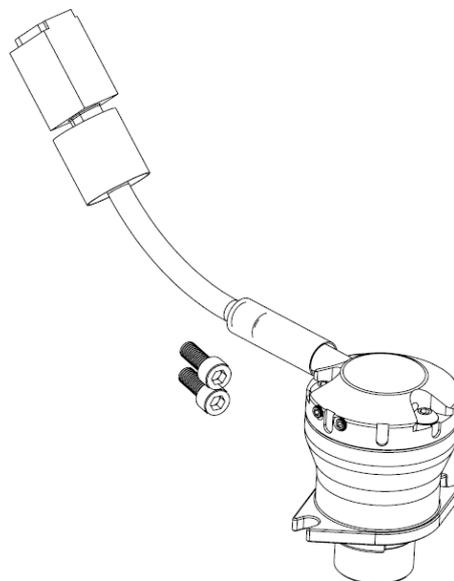
Figure 1 - Kit Contents

Part	Description	Use
1	Turbosmart EM Series BOV	Main unit
2	2x Allen Bolts	Allen bolts for mounting Kompact to mount

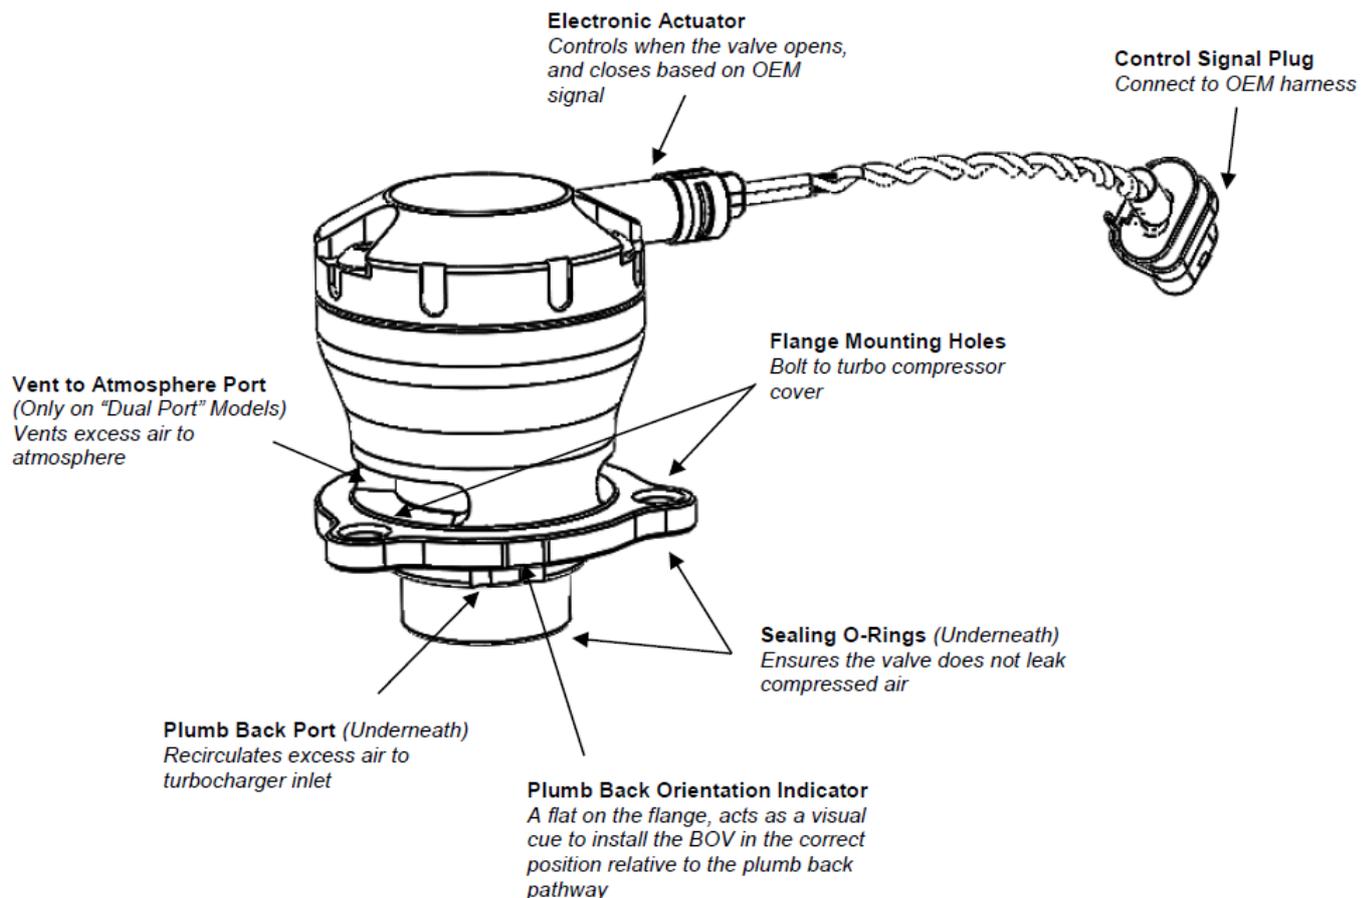
Figure 2 - EM Series BOV Overview

The EM series BOV is available in two configurations, Dual Port and Plumb Back. The functionality of the BOV is still the same, there is no performance difference between the two units, it is a personal preference if the user wishes to utilise a classic vent to atmosphere sound or revert all bypass gasses back into the inlet tract of the turbocharger.

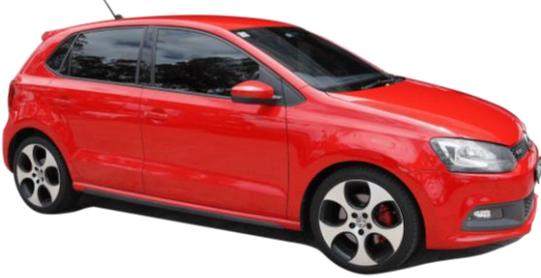
1 Identify diverter valve location.

On the model designation MK5 Polo GTI (TYP 9R) the Diverter valve is located right next to the turbo. It is hidden under the engine cover. It has been located using the white circle below.

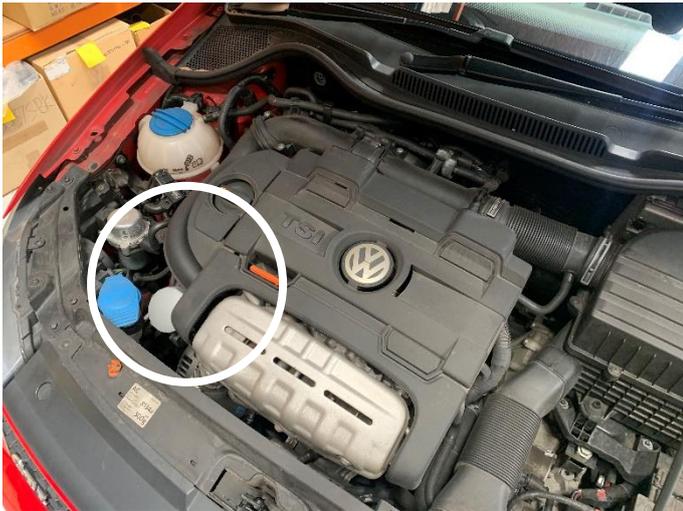
If the diverter valve cannot be located, seek assistance from your local specialist.

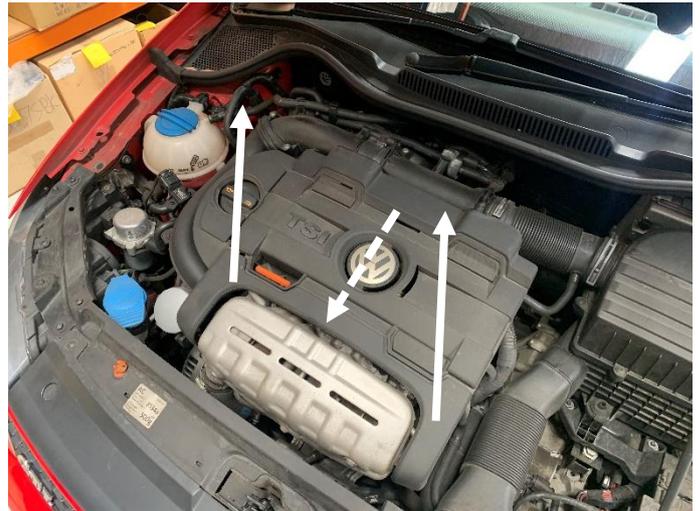
2 Removing the OEM engine cover.

the Engine cover will need to be removed. The cover is removed by lifting the front (nearest the bumper) (White Arrow) and then pulling forward (Dashed Arrow)

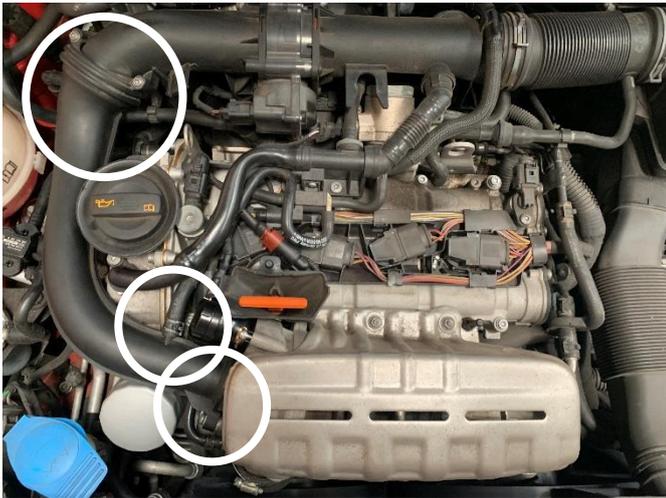
3 Removing the OEM Charge Pipe

Remove the Turbo Inlet Charge Pipe, this is fastened to the turbocharger with a single T30 Torx bolt. Making sure to not drop it into the engine bay.

The opposite end is fastened using a bracket that clamps the hose to the inlet. These two T30 Torx also need to be removed. The pipe and bracket may require a little bit of movement to get them to unseat.

The breather hose can now be removed. It is held on with a clamp that can be taken off with pliers.

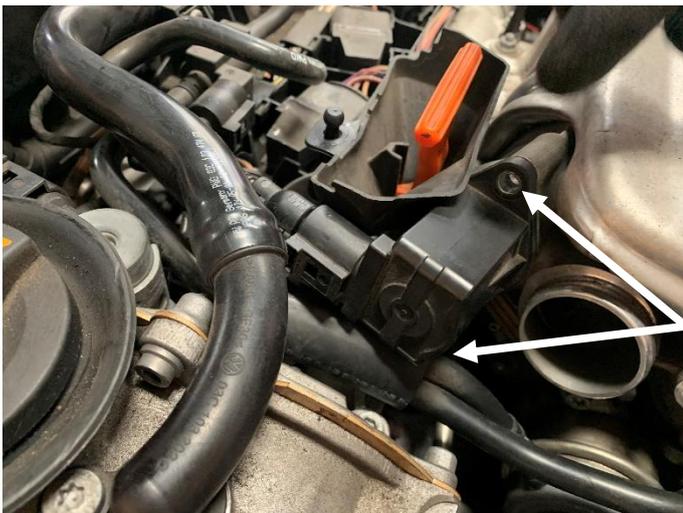
4 Removing the OEM Diverter Valve

Undo the two T30 bolts holding the valve on. There is a lot of clearance on top of the engine bay to remove the top one. It is a little bit tighter to remove the bottom one and some care should be taken to ensure that the T30 bit is correctly seated during removal as to not round off the fragile bolts. Once both bolts are out, the unit can be unseated.

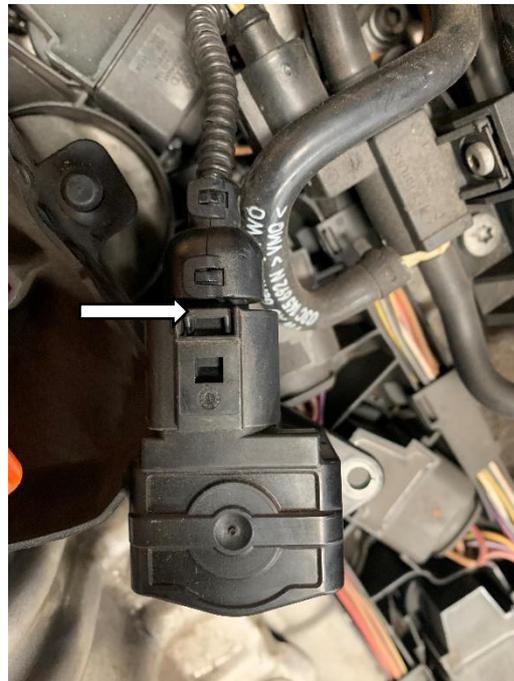
5 Removing the OEM Electrical connectors

Next, we need to remove the OEM electrical connector. The connector must be pushed down on the arrow to allow the male part to be removed. Take care as these connectors can be very fragile.

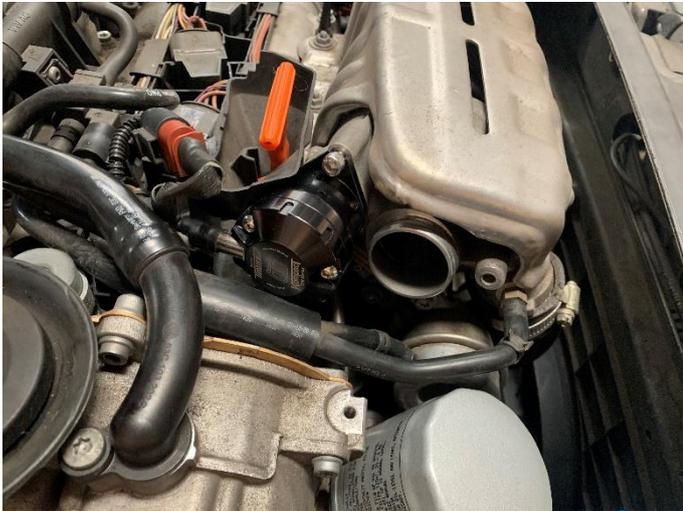
6 Mounting your EM series BOV

Install the Turbosmart Valve, remembering that the install is the opposite of the removal. Firstly, install the new valve in place. Making sure that both O rings are present and in place making sure they remain in place tightening them up. The original T30 bolts will be replaced by an Allen cap head bolt that uses a 5mm Allen key. Please consult your service manual for the correct torque specifications.

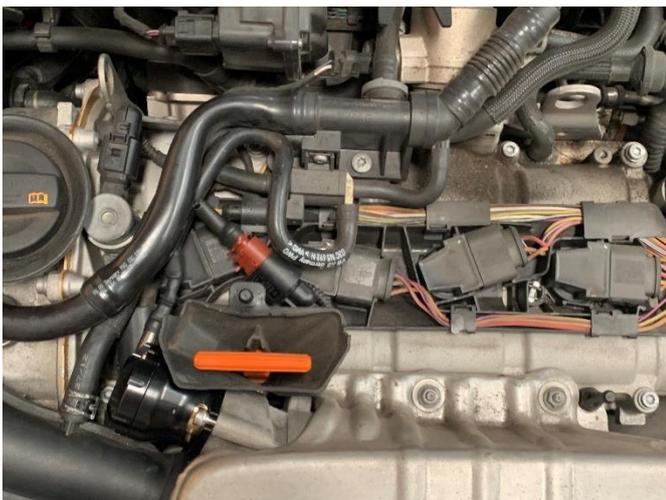
7 Connecting the Turbosmart Electrical connectors

Once the valve has been mounted, connect the electrical plug into the OEM factory plug and secure the wiring safely away from a heat source. Ensuring to hear a click of the connector locking together.

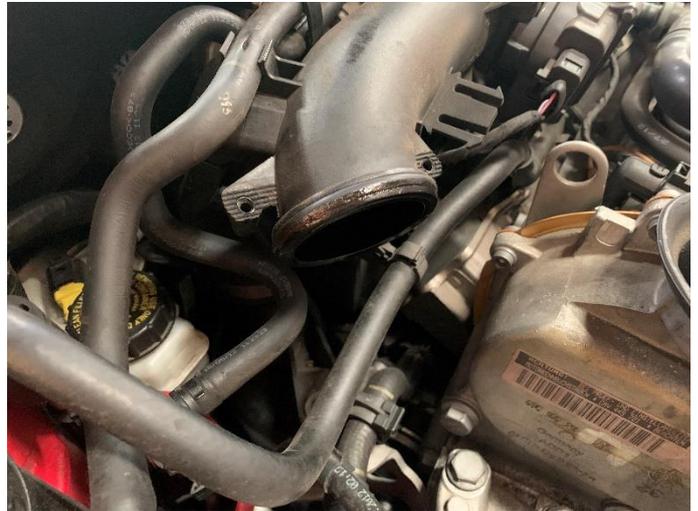
8 Connecting the OEM Charge Pipe

Place the OEM Charge pipe into its groove as well as making sure that it is seated on the inlet of the turbo. Firstly, connect the turbo inlet first ensuring the spacer is going to go into the bracket. As seen below. Then connect the bracket that clamps the charge pipe to the rest of the intake. The breather hose will need to be connected back onto the intake.

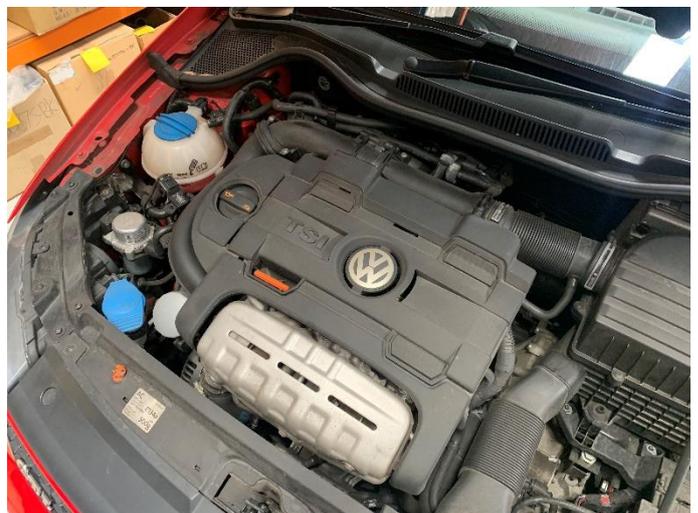
9 Finalising the install

The engine cover can now be connected back to the car ensuring the Oil dipstick is correctly seated in its groove to avoid the engine cover from interfering. The cover is firstly connected at the back and then pushed down from above. The reversal of the removal

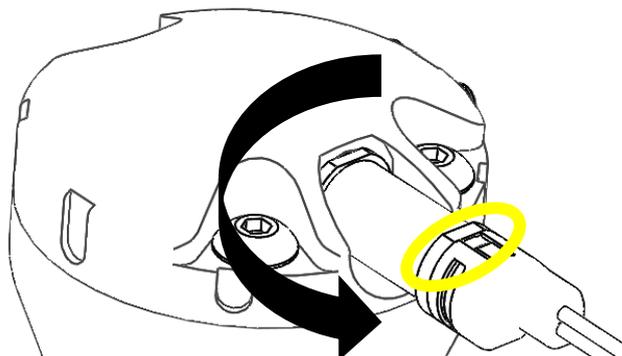
Using a 11mm open end wrench in the flat sides of the solenoid, undo the actuator in an anti-clockwise direction when viewed from the end. Ensure the wrench is placed on the metallic portion of the flats and not on the plastic cover.

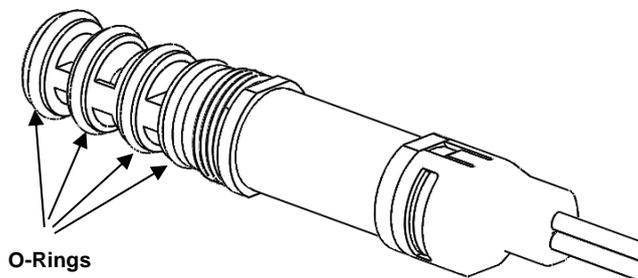
Ensure the O-rings on your new actuator are correctly seated in the grooves before installation.

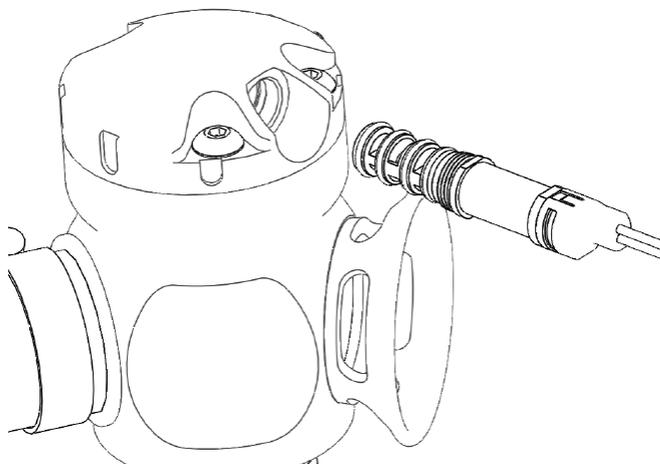
Slowly insert the new actuator while turning in a clockwise direction to avoid tearing the O-rings.
