## Repair solution for the water pump gasket

**B47.470** | Suitable for BMW | MINI

TS1 09/2025

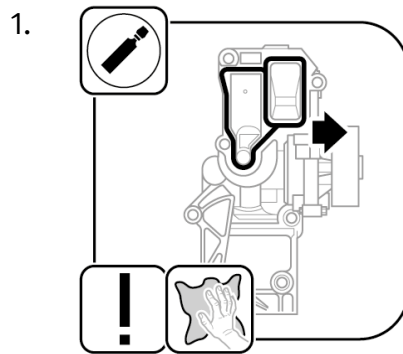
The old gasket is first removed using a suitable tool. Before installation, make sure that the surface is clean and free from residue. Sealing compound points (see Figure no. 2) must be applied to ensure that the gasket remains in the correct place during installation. To ensure that the EPDM gasket functions perfectly, you should wait 30 minutes after installation.
