Early failure from heater and radiator by contaminated cooling system after a exchange

By cars with integrated turbocharger heaters the rate of failure by leakage after an exchange increases.

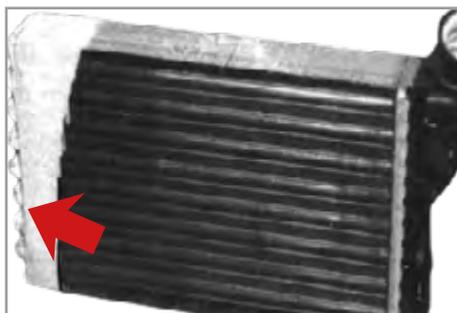
Picture 1 shows an absolute permeable heater installed since 9 months in a car.

The leakage accumulates mostly in the near of U-arches. Different manufacturers researched and find out if the cooling was not cleaned or flashed before the exchange; contaminants will stick on the turbocharger and causes an early failure.

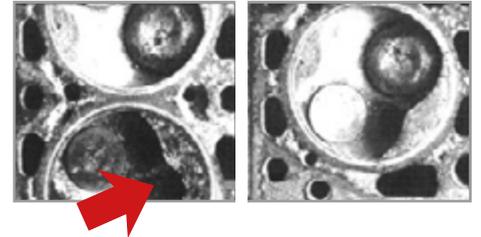
Picture 3 shows how the corrosion corrodes aluminium tubes in the cooling block when the cooling system was not efficiently cleaned or flashed, or used to less or wrong frost protection.

Picture 4 + 5 (top) shows the cylinder head top with the affected by using to less or wrong frost protection. The released metallic contaminant circulates in the cooling system and blocks the little openings as the U-arches in the heater.

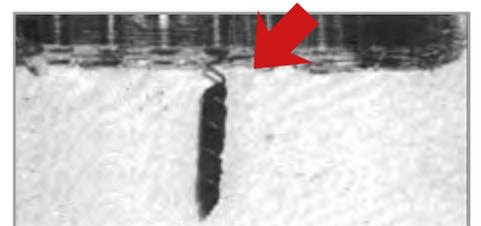
Picture 6 (bottom) shows contaminant accumulates to the turbocharger which accelerates the corrosion process.

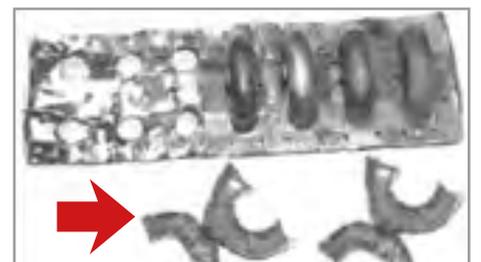
Picture 7 (bottom) shows any cut open U-arches. Inside the U-arches are visible traces from contaminant.
