To fit:  
Ford Fiesta VI 2008 – 2017

## Axle Beam Mount for rear axle support

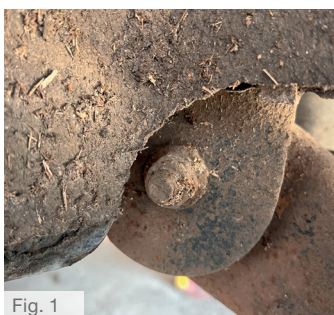
Fig. 1

Slacken the two mounting bush retaining bolts. (Fig.1)

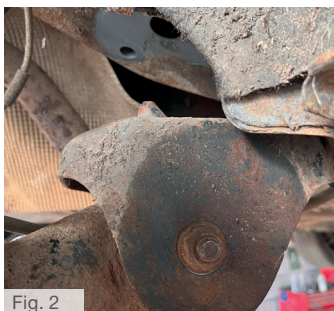
Fig. 2

Remove the three securing bolts retaining the brackets from each side and gently lower the axle, then remove the bush retaining bolts. (Fig.2)

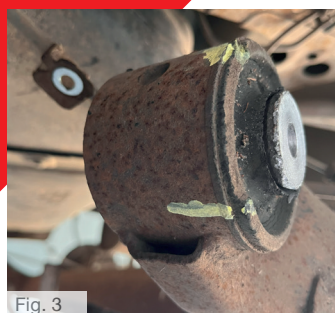
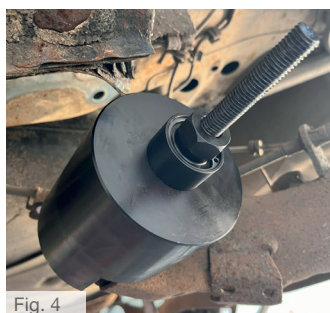
To remove the axle beam mounting, first mark the alignment of the bush to the axle and extract using the special tool. (Fig. 3 & 4)

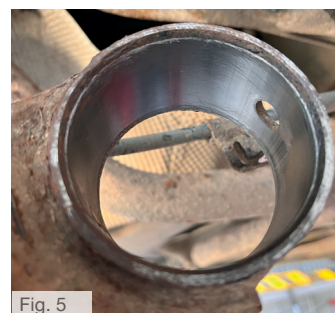
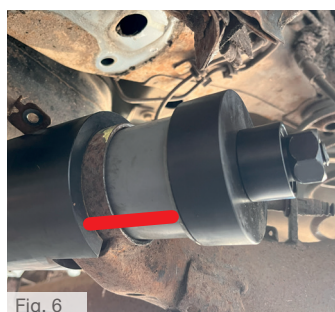
Clean all mating surfaces being sure to remove any corrosion and road debris and then apply a small amount of petroleum jelly or lithium grease such as febi 31942 around the new bush to aid insertion. Align the new bush to ensure the correct orientation before pressing the new mounting into the axle, then repeat for the other side. (Fig. 5 & 6)

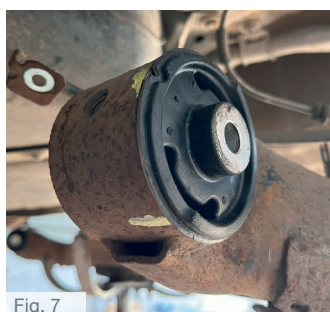
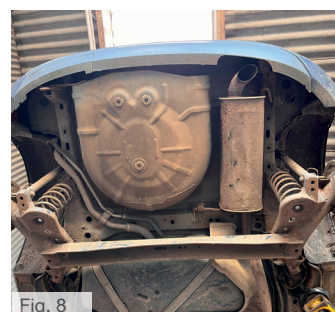
With the new axle beam mounting bushes replaced, refit the brackets to each side and raise the complete axle into position. Tighten the body bracket bolts to 125 Nm and then resecure the ABS speed sensor wiring and hand brake cables. Fig 7 & 8)
