# SWAG 50 94 4493

To fit: Ford C-Max II, Focus III,  
Grand C-Max II, Transit II Connect

Engine: 1.0 EcoBoost

## Engine Mounting

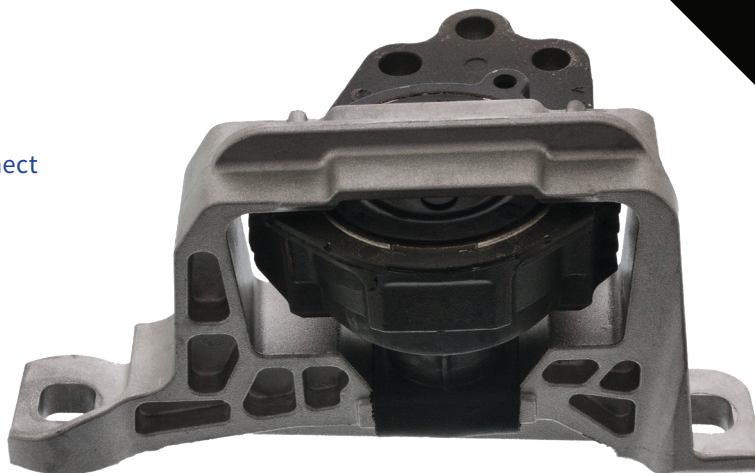
When the engine is idling, a whining, vibrating, humming noise can be heard inside the cabin area.

Exposure to the elements and hot and cold heat cycles leads to the degradation of the rubber component of this hydraulic engine mounting. This results in the hydraulic fluid seeping out, causing excessive movement of the engine mounting.

Confirm the vibration is being caused by the engine mounting. This can be done by increasing the engine speed to see if the noise goes or changes tone.

Using an assistant, manipulate the mounting by adding pressure to it with a lever bar and applying a load to the engine mounting in several areas. If the noise goes or hydraulic oil can be seen leaking, the mounting should be replaced.

Due to the excess movement caused by this failing engine mounting, it can cause stress to the lower engine mounting leading to it becoming weak. SWAG replacement part 50 94 5855 is also available if required.

Therefore, it is recommended that when diagnosing engine mountings all are checked.
