SWAG 50 93 4748

To fit: Ford Fiesta VI 2008 – 2017

Axle Beam Mount for rear axle support

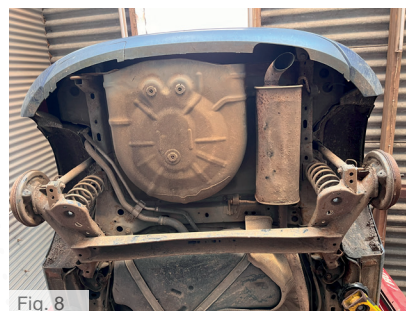
Fig. 8

With the new axle beam mountings replaced, refit the brackets to each side and raise complete axle into position tighten the body bracket bolts to 125 Nm, resecure the ABS speed sensor wiring and hand brake cables. (Fig 7 & 8)
