BM91533H: FITTING ADVICE

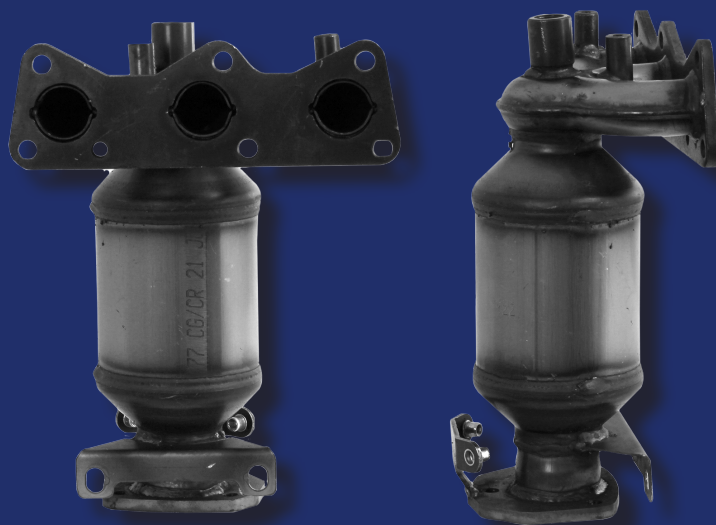
- Fit the replacement unit (loosely to begin with) to the engine using a new gasket at the cylinder head.
- Make sure that the support bracket positioned above the three-bolt flange is loosely bolted to the engine. Failure to fit support brackets could result in the unit breaking at its weakest point due to stress caused by excess movement.

- Once it is lined up and correctly in position, proceed to tighten all nuts from the centre outwards; this should pull the unit to the cylinder head evenly, creating a tight seal.

- Ensure that the support bracket is tight.
- Once the unit has been securely fitted, the unit can be connected to the next part of the system (connecting pipe) using a new gasket.

- When removing the old unit, sometimes the studs holding it to the cylinder head wind out slightly; ensure that they are screwed back in fully to create an airtight seal with the new unit.

- Once the old unit has been removed, ensure that all contacting surfaces are clean and that all traces of the old gasket are removed from the cylinder head. Failure to do so could result in an exhaust leak.

- When refitting the lambda sensor, take care to ensure that the wires are not twisted.
