TSB - M102

MITSUBISHI - LANCER CC - CD 1.8Ltr & 2Ltr GALANT VR4
BEFORE REMOVING GEARBOX ASSEMBLY

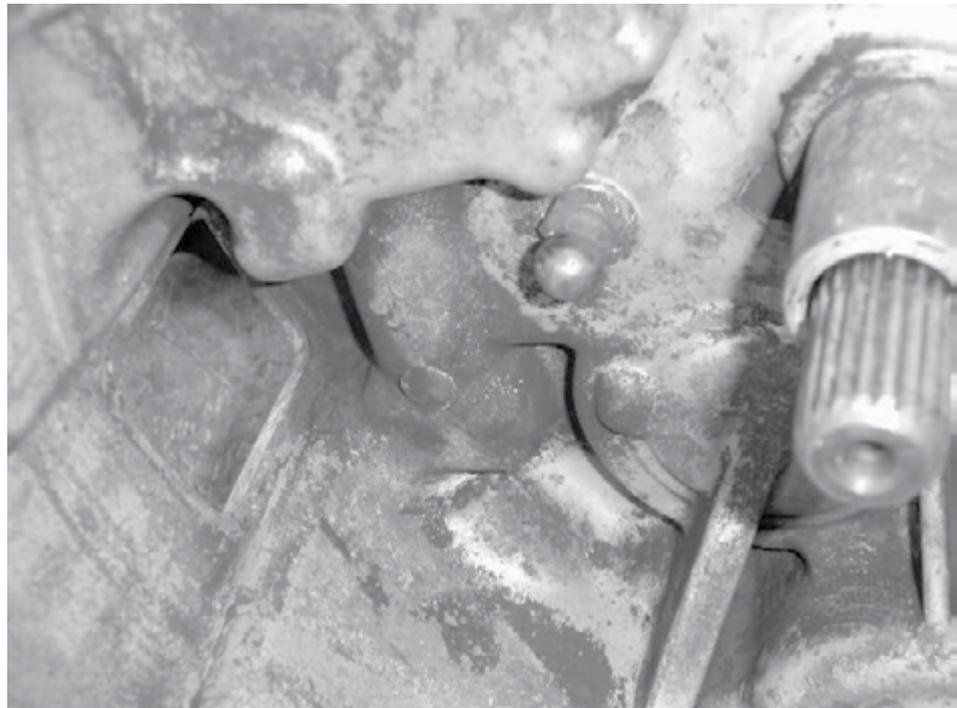
1. After removal of gearbox, clean all components. Check gearbox bearing nose cone for wear. If worn, it must be replaced to avoid pedal graunch and notchy feel when new clutch is installed.
2. Check clutch fork pivot ball seat and the pivot ball for wear. NOTE: The clutch fork in this model vehicle is made of cast iron and is prone to wear. If any wear is evident, the fork and pivot ball must be replaced. WHEN FITTING THE NEW CLUTCH YOU MUST FIT the spacer supplied behind the pivot ball.
