REMANUFACTURED AIR STRUT SERVICE BULLETIN

1 | 11-TSB7-J REV 3 05/30/2019

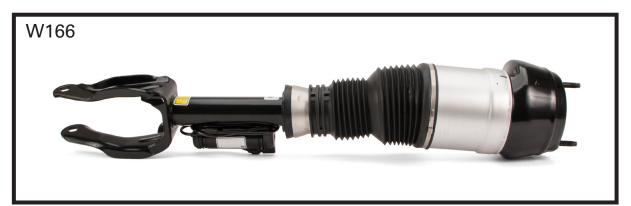
UPON VISUAL INSPECTION OF YOUR AIR STRUT, IT MAY
APPEAR THAT THE AIR STRUT IS BENT. THIS IS COMPLETELY
NORMAL AND THE AIR STRUT WILL STRAIGHTEN OUT WHEN
PROPERLY INSTALLED ON THE VEHICLE.

THIS IS NORMAL (AS-3060, AS-3061)

DO NOT RETURN AIR STRUT DUE TO THE VISUAL APPREARANCE OF IT BEING BENT.

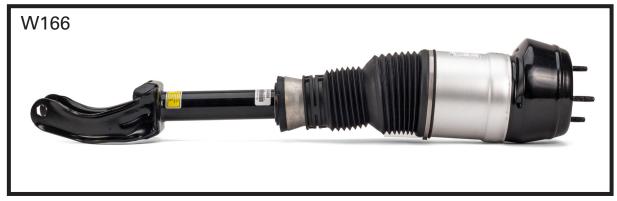
THIS IS NORMAL (AS-3085, AS-3086)
