TURBOCHARGERS – RECONDITIONED, EFFICIENT, AND POWERFUL

TURBO BY INTEC THE BRAND FOR TURBOCHARGERS

The Reconditioning Process

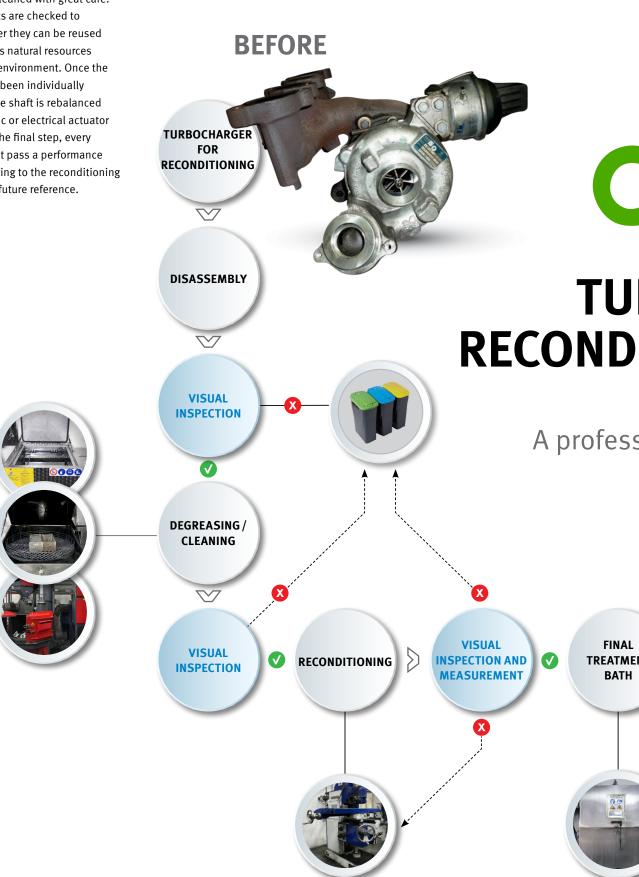
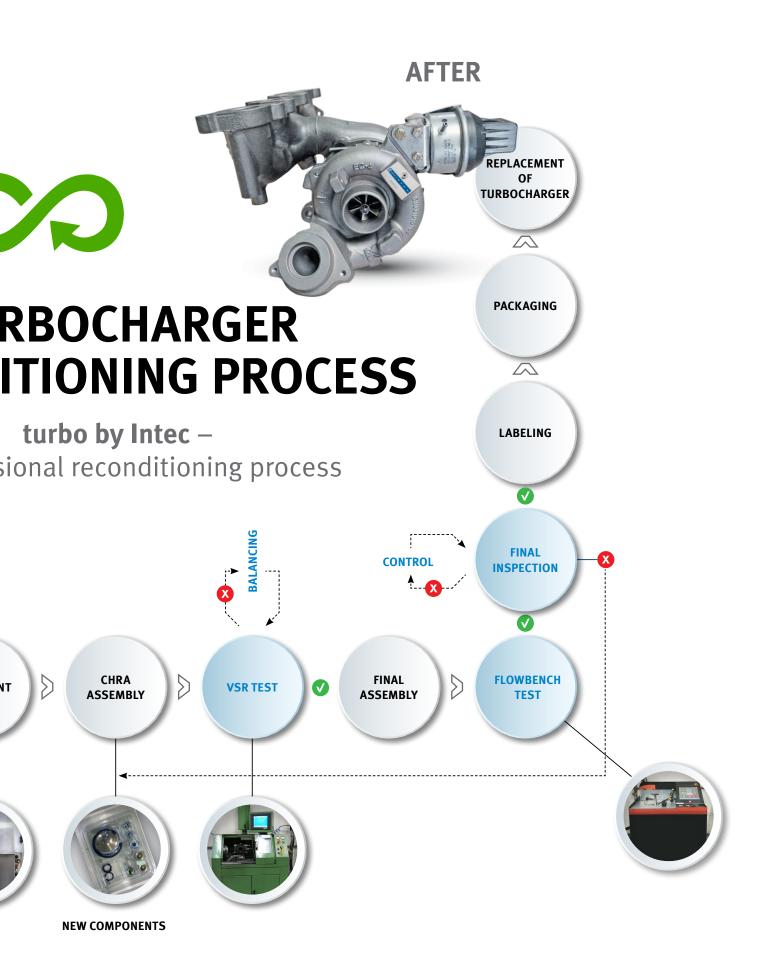
Each turbocharger is completely dismantled and cleaned with great care. All individual parts are checked to determine whether they can be reused - which conserves natural resources and protects the environment. Once the turbocharger has been individually rebuilt, the turbine shaft is rebalanced and the pneumatic or electrical actuator is calibrated. As the final step, every turbocharger must pass a performance test. All data relating to the reconditioning work is saved for future reference.

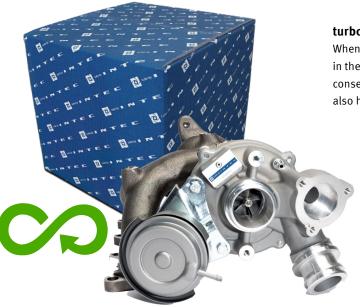
Operating Principle of Turbochargers

The exhaust gases produced during combustion drive a turbine, which is connected to the compressor impeller by a shaft. The compressor impeller on the latest and smallest turbochargers rotates at speeds of up to 400,000 revolutions per minute. It compresses the intake air and thus increases the air mass provided to the engine. This enables ${\rm CO}_2$ emissions and fuel consumption to be minimized while also increasing performance.
