BULLETIN 0002

Ford 2.0 diesel - FWP 1948 & FWP 2063

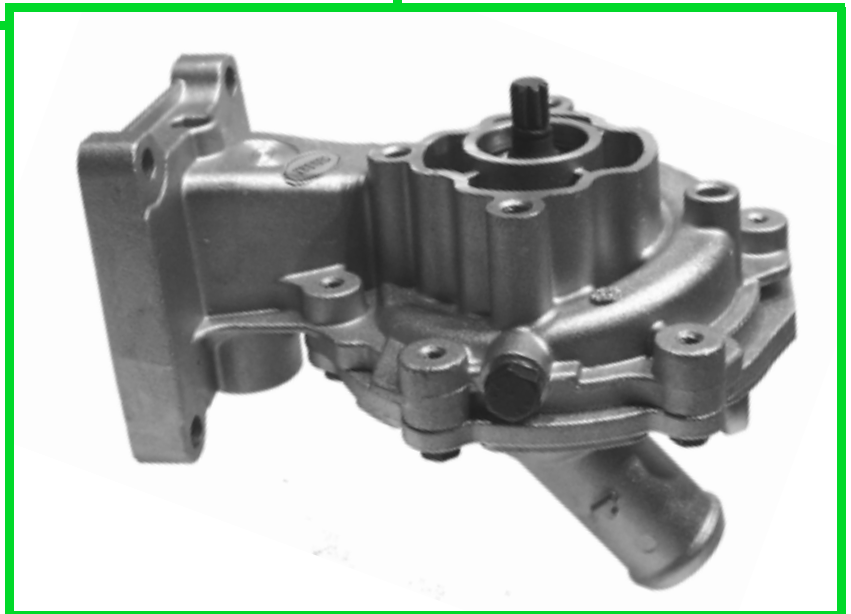
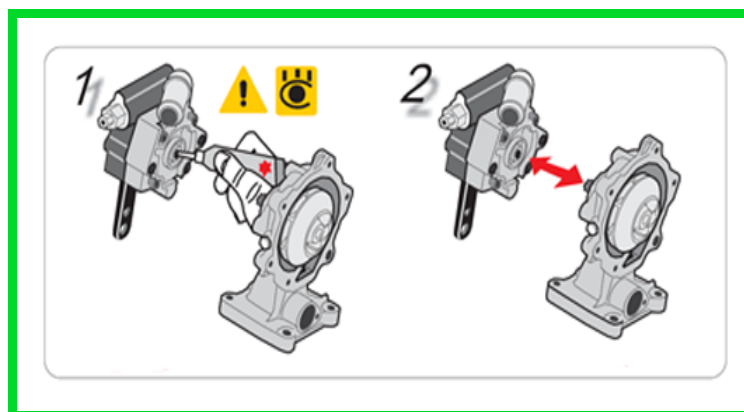
Examination of the condition of the splined drive from the power steering pump **MUST** be made prior to the installation of the new Water Pump. If there is any evidence of wear the power steering pump **MUST** be replaced.

Remove all traces of old grease from the pump drive shaft splines, remove and discard the old 'O'ring seal.

Install the new 'O' ring and apply the contents from the grease sachet to the power steering pump drive splines before fitting the new Water Pump

The seal and grease sachet can be obtained by ordering

FIRST LINE part FWK 001
