## SERVICE ENGINEERING BULLETIN SB2125.1

# Valve head cracking / breaking

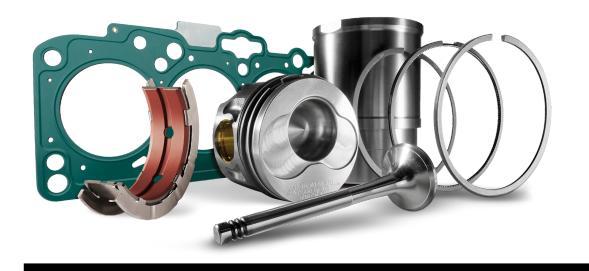
#### **1.Valve Headchordal Failure**

This is the most typical form of valve head failure. The valve head breaks through a chord line, i.e. a failure stretching across two points on the circular edge of the valve head. This usually produces considerable secondary damage to the piston, cylinder head and sometimes the cylinder bore.

This is a fatigue type failure, the causes of which are:

- The valve head's inability to stand up to the stresses from the gas loading.
- The valve head temperature effect on the ultimate tensile strength of the valve material.

The initiation point is usually about halfway up the underhead radius. This does vary to some extent according to the section design of the valve head. This is a problem mainly confined to the engine manufacturer during the development of a new or uprated product but it can occur in service. Although the term chordal is applied, there may be many variations on the shape of the developing crack. This sometimes travels a considerable way round the underhead radius before propagating out to the valve seat. Fundamentally, the skin of the underhead radius at some point being too highly stressed causes such valve head failures. In service the reasons for this could be:

a. Excessive load on the engine coupled with over-fuelling or other maladjustment, resulting in excessive valve temperature and gas pressures.

b. Poor finish on the underhead radius on highly stressed valves. Note, some valves are shot peened or spiral-polished to increase resistance to skin fatigue.

c. Damage marks on the underhead radius.

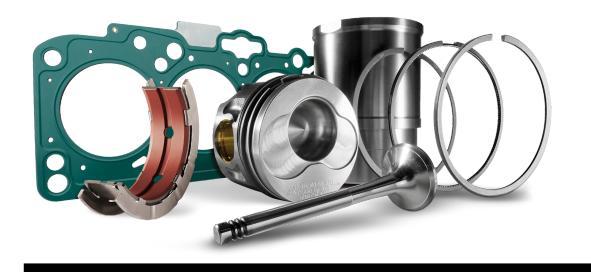
#### 2. Valve Head Tulipinge

In this instance, the head of the valve cups downwards resulting in poor sealing and loss of power. This relates to chordal failure as environmental conditions, valve head design and type of material initially produce a plastic flow. However, it is possible to spot valve tulipinge before final chordal failure occurs due to the resultant poor sealing and power loss.

With this type of condition, current belief is that plastic flow increases due to over-speed dynamic effects.

## 3. Radial Rim Crackling of Inlet and Exhaust Valve Heads

"Radial Rim Cracking" of inlet and exhaust valve heads is also traditionally known as "Thermal Fatigue". Research over the last few years has clearly indicates that many failures attributed to classic thermal fatigue have other factors influencing the result. A radial crack is one that starts in the rim of the valve and travels inwards to the centre of the valve.

As with chordal failures, these failures also vary. Sometimes the propagation line turns through 90°, travel across the valve head in the form of a half chord and, then travels back to the valve seating face. The piece that breaks away is roughly triangular in form. In other cases, the initial crack line branches into a 90° turn to both left and right. This produces two triangular breakaway pieces that are very often lost. Initially it appears that the valve has a chordal failure. These failures may sometimes be obvious but, in other cases, they may require expert identification.

The causes of true thermal fatigue are:

a. Extreme cyclic temperature variations throughout the valve head. Excessive temperature and pressure in the combustion chamber bring these about.

b. Continually overloading of the engine followed by abrupt unloading or frequent engine shutdown after high loading.

c. Poor temperature distribution across the valve results in high tensile rim stresses. Abnormal deflection of the valve head due to excessive combustion pressures often accompanies this.

d. Damage marks on the rim produce stress raisers

e. The rim or peripheral land of the valve head is too thin and with sharp edges. This is usually due to too frequent reclaiming or regrinding.

- f. Pre-ignition conditions
- g. Incorrect material specification.

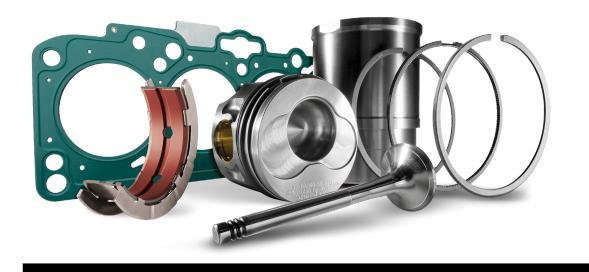
#### 4. Burn Through On Rear of Valve Face

On occasions, a hole burns through the exhaust valve head at the back of the seating face that leaves the seating face virtually unmarked. Close examination, however, shows the start of the failure is a rim crack. With rapid erosion of the valve head material, combustion gases can escape through the crack. This is also another example of radial rim cracking or, thermal fatigue.
