TECHNICAL

BULLETIN

Bulletin Ref: TB11a

80amp Korean Fuse

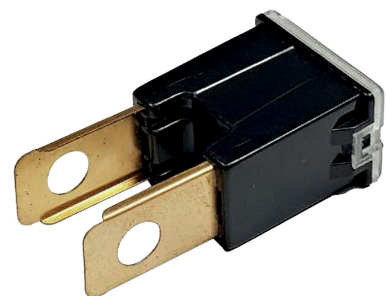
**Fig 1.**

Before fitting check the 80a PAL type fuse as this fuse can blow causing no charge. (Fig1.)

Also check for corrosion around and underneath the fuse connections which is common.
