#### Frequent causes of damage:

# Bad location for the electric switch-over valve (EUV)

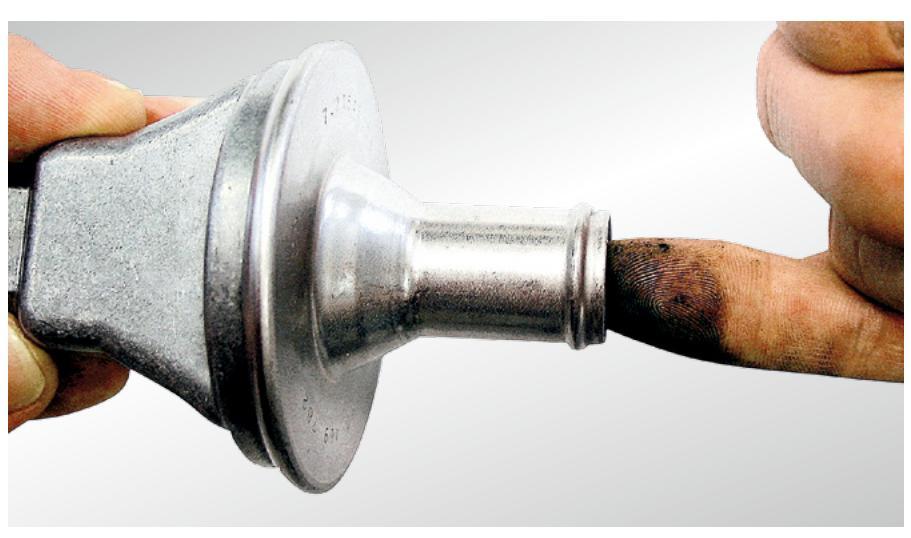
Fig. 32: simple check of the check valve

Non-return valves can be checked for leaks

very simply:

- Release the connection hose on the nonreturn valve that leads to the secondary air pump.
- If there are deposits on this side of the valve (for the finger test, see illustration), the non-return valve is leaking and must be replaced. In this case the secondary air pump may already be damaged. Check the secondary air pump and replace as well if necessary.

If oil vapours (blow-by gases) get into the non-return valve from the inlet port here, the valve can become so stuck that it will also remain closed when the secondary air pump is running.
