To fit:
Vauxhall/Opel Corsa D, Adam

Fresh Air Nozzle

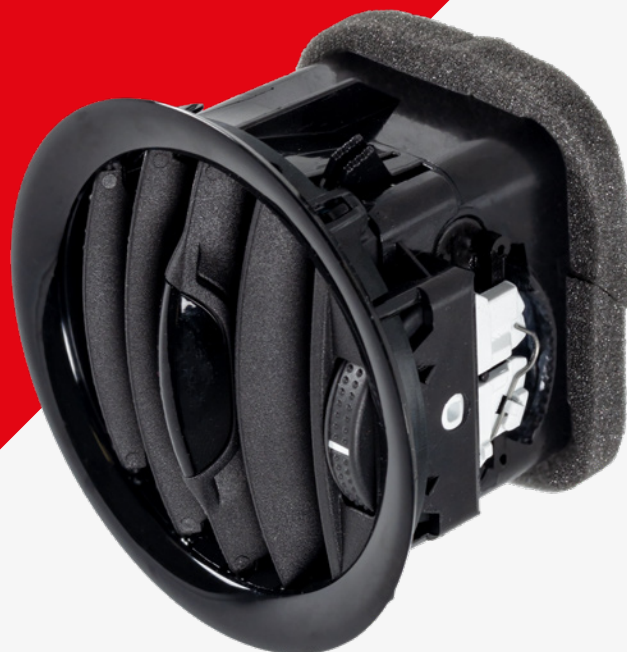
The air distribution adjustment fins do not stay in the required fixed position.

The adjustment of the airflow direction through the fresh air nozzle is adjusted by moving the fins into the desired position, while the volume of air flow into the cabin is controlled by the wheel at the side. Over time the lever controlling the directional fins can wear to the point of disconnecting, breaking and falling into the heater ducting. The use of an accessory mobile phone holder, which clips into the air vent nozzle, can over-stress and break the nozzle. Excessive force used to operate the adjuster wheel can also break the spring tensioner tabs.

Remove the broken fresh air nozzle by using two thin-blade screwdrivers to disconnect the nozzle from the dashboard. Working with two at a time, there are four moulded tabs to be released - located in the 02:00, 04:00, 08:00 and 10:00 o'clock positions. Once all four tabs are released, the nozzle can be removed. The outer-trim ring does not need to be removed. To fit the new nozzle, align the four tabs and push firmly into position.
