# TROUBLE TRACER CHART VALVE TRAIN

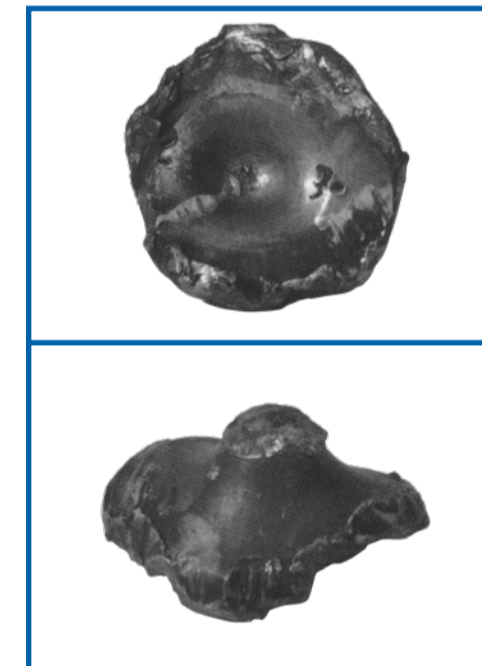
## Valve head breaking off stem

**Symptom:** Rough engine with sudden mechanical noise.  
**Cause:** Mechanical overload, such as seating velocity too high from excessive valve clearances. Valve bounce, valve to piston contact caused by overspeeding, weak or broken valve springs or sticking valve stem. Uneven seating due to misalignment or distorted valve.  
**Remedy:** May not be possible due to extreme damage this failure can cause, however: Check valve springs, guides and alignment and repair where necessary. Check seat guides, pistons and bores for damage. Reset the valve clearances.

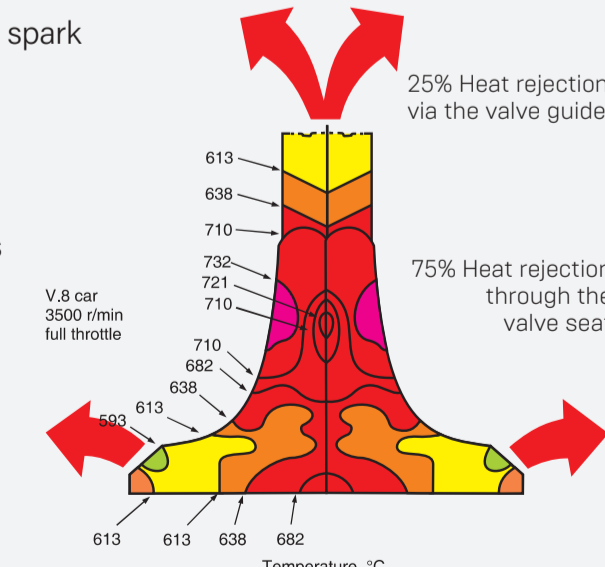
- Typical exhaust valve temperature distribution in a spark ignition engine. Figures are degrees in centigrade.
- An exhaust valve may operate at up to 800 °C, and 75% of its cooling is by transferring heat to the valve seat.
  - Ensure the valve seat contact is correct and as specified by the engine manufacturer.
