CLUTCHTECH

TSB-184

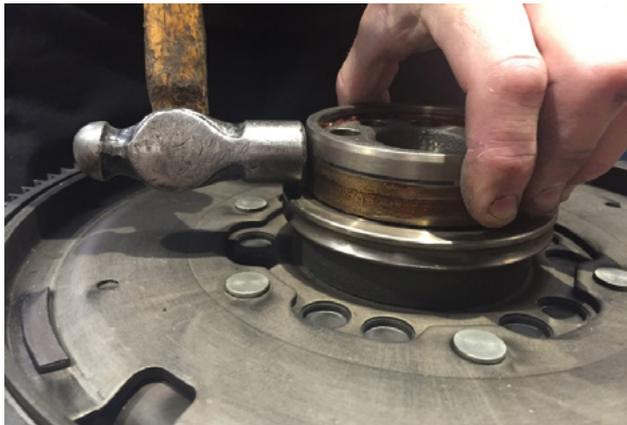
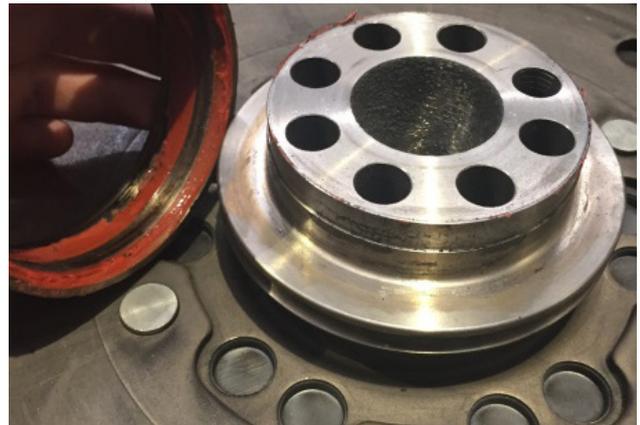
This dual mass flywheel requires the locating ring for the rear main seal to be removed from the old flywheel and reused on the new unit before installing on the engine. Failure to do this will result in the rear main seal leaking excessively.

1. Remove the ring from the old flywheel by pulling up on the ring and lightly tapping around the outer edge of the ring with a hammer. Be careful not to damage the sealing surface.

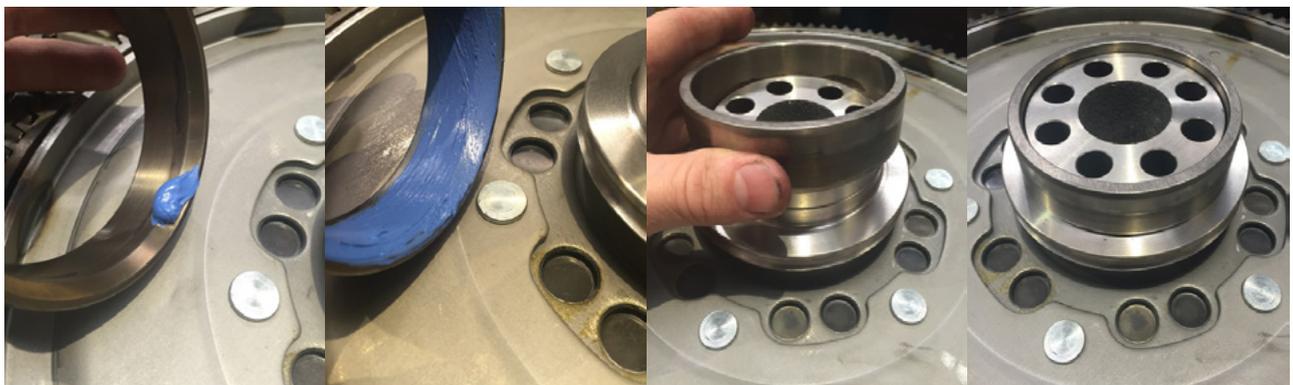
2. Thoroughly clean the seal surface and the inner locating surface to ensure that the ring locates on the new flywheel correctly.
3. Apply a small amount of silicone gasket to the locating diameter of the ring and slide it onto the new flywheel.
