TSB-225 Input Shaft Seal Replacement

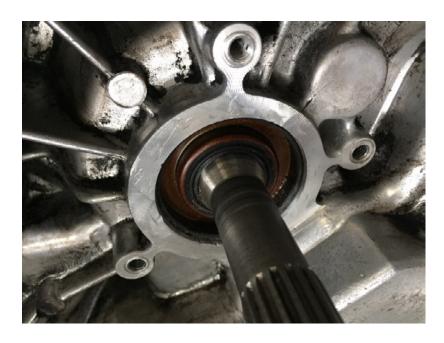
Note depth of original seal before replacement as a guide to ensure the new seal is seated correctly.

When changing the front input shaft seal, it is important to ensure that the seal is seated correctly and the concentric slave cylinder (CSC) is mounted square to the machined mounting surface. If the seal is not seated correctly, the CSC may sit proud or off-axis and cause damage to the CSC and clutch assembly.

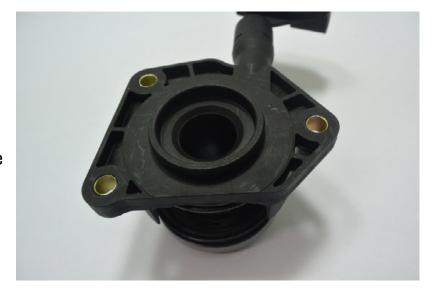
Once bolted up check that the concentric slave cylinder is sitting square to the machined surface on the gearbox before operation.
