TSB-303 GM Service Kits

Before fitting this service kit, please check that it is compatible with your flywheel.

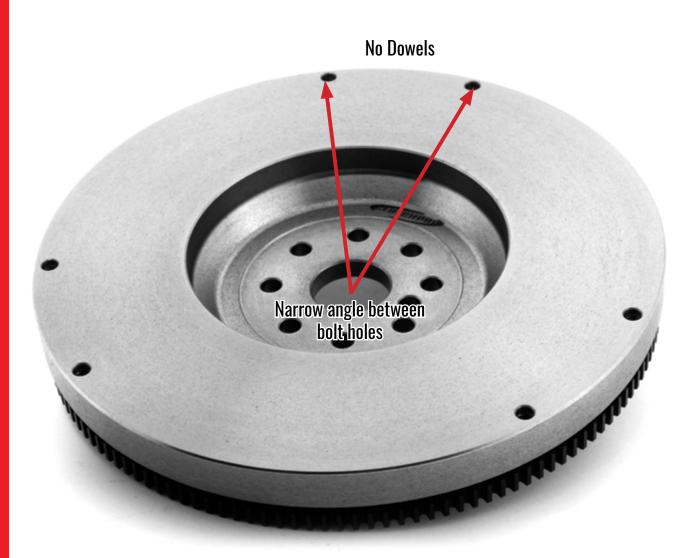
FGM115 Service kit: KGM26030

Failure to fit the correct kit to the correct flywheel could cause over-stroking of the CSC resulting in a broken CSC and contamination of the clutch components. Fitment of the wrong components is not a warrantable issue.

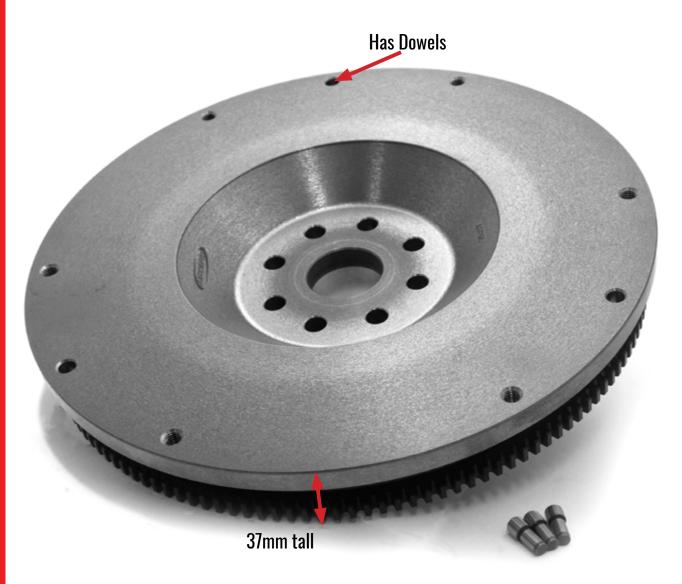
FGM125

Service kit: KGM26031 Vehicle will have a CSC Spacer. This spacer will need to remain on the transmission with the installation of the new kit.

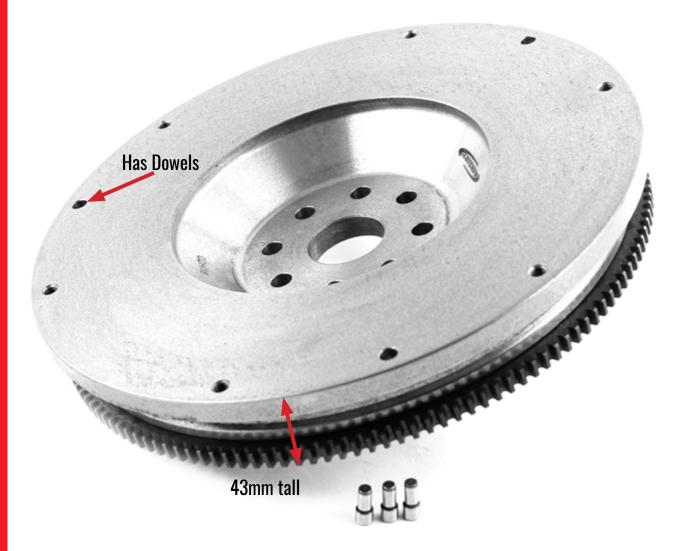
FGM159 Service kit: KGM26031

Does not have CSC Spacer.
