## TSB-BM02

### Correct Fitment of Driven Plates

*Applies to ClutchPro kits:*  
**KBM23003**  
**KBM23005**  
**KBM22005**

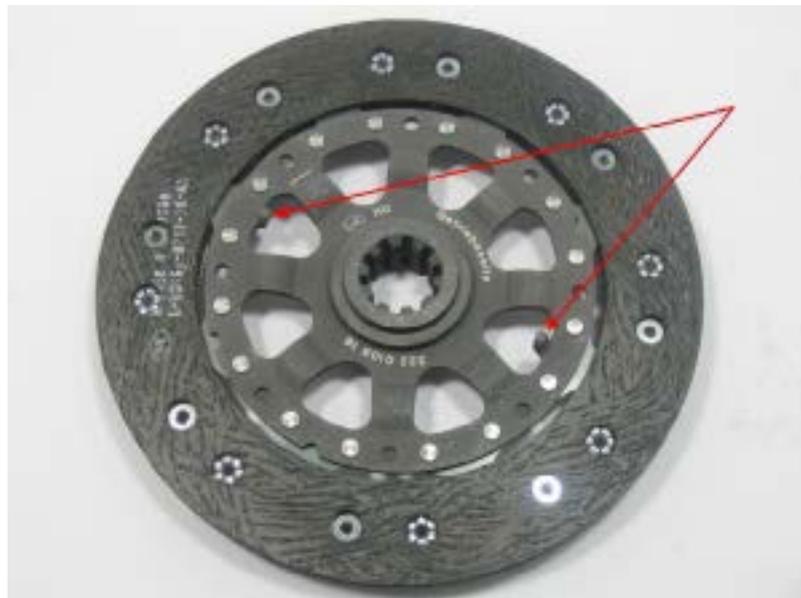
When fitting a KBM23003, KBM23005 or KBM22005 matched kit to BMW 3-series E36, 5-series E28, 5-series E34 or 5-series E39 vehicles the driven plate must be fitted with the two raised lugs on the main plate facing towards the gearbox.

Failure to fit the driven plate correctly will cause the driven plate main plate to foul against the flywheel bolts, resulting in clutch non-release problems in the vehicle.

Please refer to this bulletin when fitting a KBM23003, KBM23005 or KBM22005 matched kit to these vehicles as clutches returned to ClutchPro with damage caused by incorrect driven plate fitment are not acceptable as warranty claims.
