PR1147 & PR1180 GEARBOX MOUNTING BRACKET

STEC.10006 25/07/22

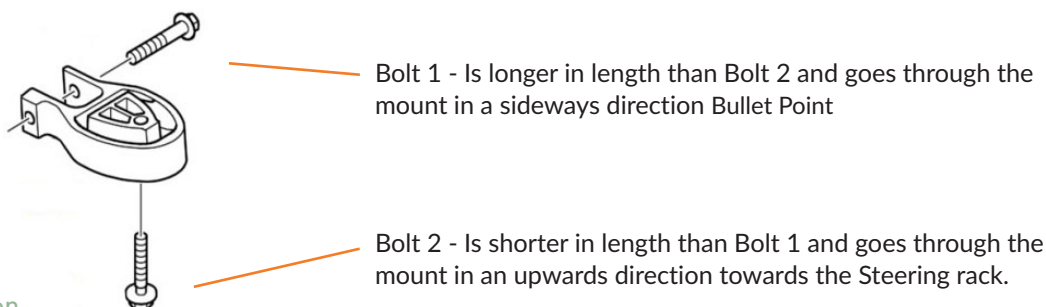
As part of the fitment process for PR1147 & PR1180 the front subframe is lowered or removed. This involves removing the lower gear box mounting (please see Fig 1 below).

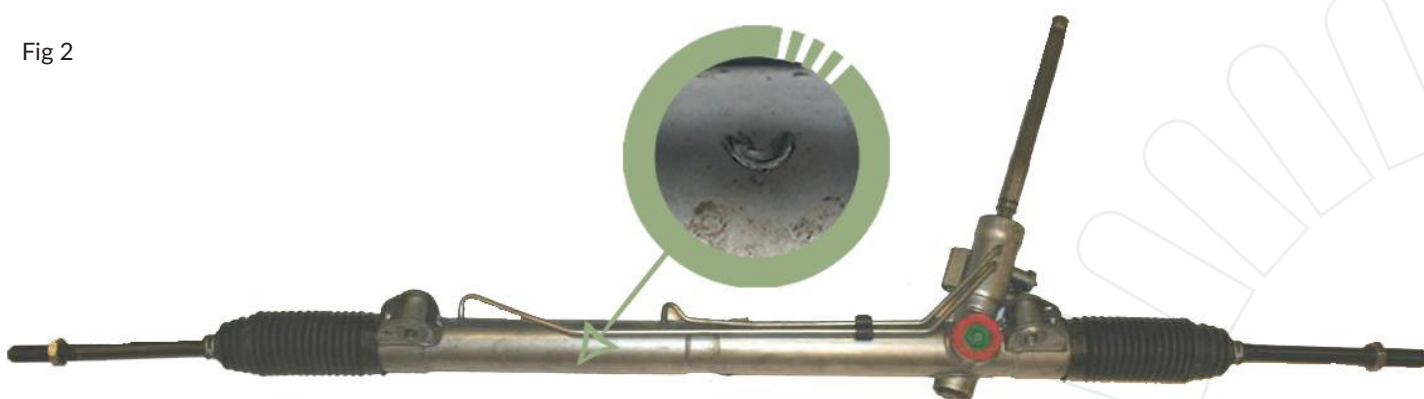
The two bolts securing the lower gear box mounting are noticeably different in length. Please pay extra attention when re-installing the bolts, as failure to insert the correct bolt in the correct location will result in irreparable cast damage to the steering rack. This damage will invalidate the warranty.

IMPORTANT: Please note this type of cast damage will result in a Surcharge Rejection

(please see Fig 2 below).
