# AUTOELECTRO

## STARTER MOTORS & ALTERNATORS

**IMPORTANT PLEASE READ THE INFORMATION BELOW BEFORE FITTING THIS PART AS THERE ARE KNOWN ISSUES WHICH WILL RESULT IN THE PREMATURE FAILURE OF THE UNIT AND MAY INVALIDATE YOUR WARRANTY**

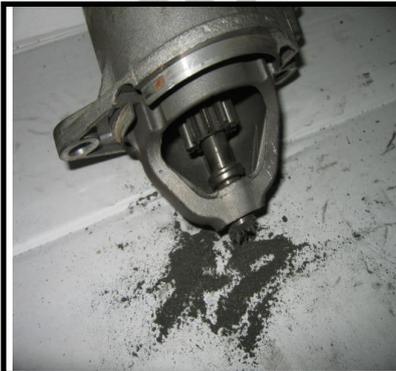
Look out for fluid residue, rust build up, distinctive smell and possible burning smell.

Signs of grey/metal dust can indicate that failure of the starter motor has been caused due to a failing Dual Mass Flywheel.

This dust can cause the bearing and gear shaft to become dry which results in the starter motor being noisy during operation and/or the pinion to stick on the gear shaft. In extreme circumstances the dust can stick to the magnets inside the starter motor and result in the starter motor exploding. Failure caused by dual mass flywheel is not a manufacturing defect and will **not** be covered under warranty.

It is critical that you visit our website to obtain information and carry out further investigations to locate the leak and rectify it prior to fitting the replacement unit. Failure to do so will cause the replacement unit to fail prematurely and will invalidate your warranty.
