# KNOW HOW

## TECHNICAL BULLETIN

### NSM1614 - Chevrolet Captiva

Bulletin Ref: TB12n

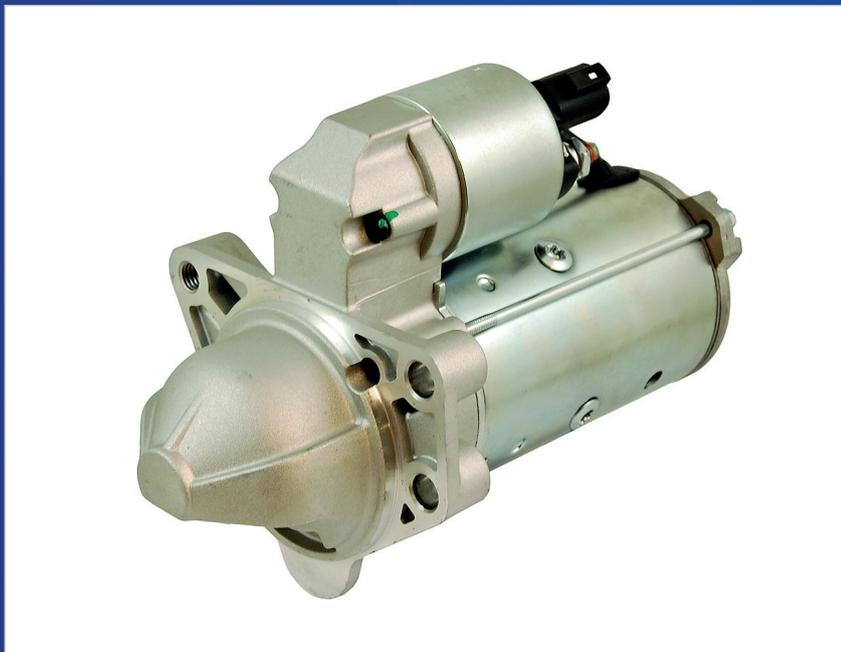
'A risk of fire while driving due to thermal damage of the starter cable'

It is vital that this is checked and replaced if the starter motor connection has melted (Fig 1).
