WICHTIGER MONTAGEHINWEIS

Kraftstofffördereinheit 2250543

IMPORTANT INSTALLATION NOTICE

Fuel feed unit 2250543

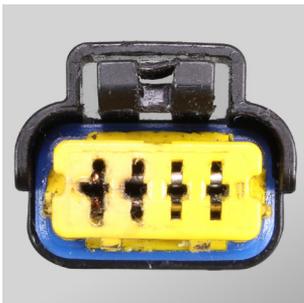
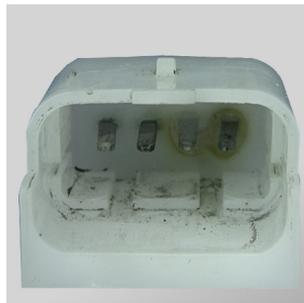
Sollten sie eine Verfärbung an den Kontakten, am Kunststoff oder Scheuerstellen an dem Stecker feststellen, müssen weitere Teile mit ausgetauscht werden.

Durch einen zu geringen Abstand zwischen dem Anschlussstecker, der Pumpeneinheit und der Karosserie kann es bei ungünstiger Konstellation zum Kontakt kommen. Dieser Kontakt kann Hochspannungsimpulse verursachen und in der Folge zu einem Überhitzen der Steckkontakte und zum Schmelzen des Kunststoffes führen.

Bitte verwenden Sie beim Austausch der Kraftstofffördereinheit zusätzlich folgenden Metzger Kabelreparatursatz: 2324101

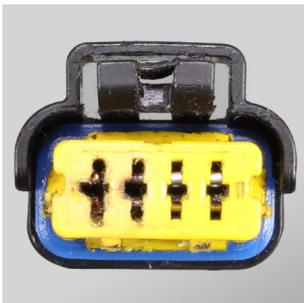
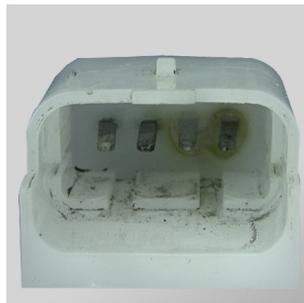
If you notice any coloration on the contacts, on the plastic or chafe marks on the plug, other parts must be also be replaced.

If the distance between the connecting plug, the pump unit and the car body is too small, contact may occur if the constellation is unfavourable. This contact can cause high-voltage pulses and lead to overheating of the plug contacts and melting of the plastic.

**Please also use the following Metzger cable repair kit
to replace the fuel feed unit: 2324101**
