# SWAG 20 94 5032

To fit: MINI (R55, R56, R57, R58, R59, R60 and R61) - fitted with the 1.6-litre N16 engine.

## Ignition coil

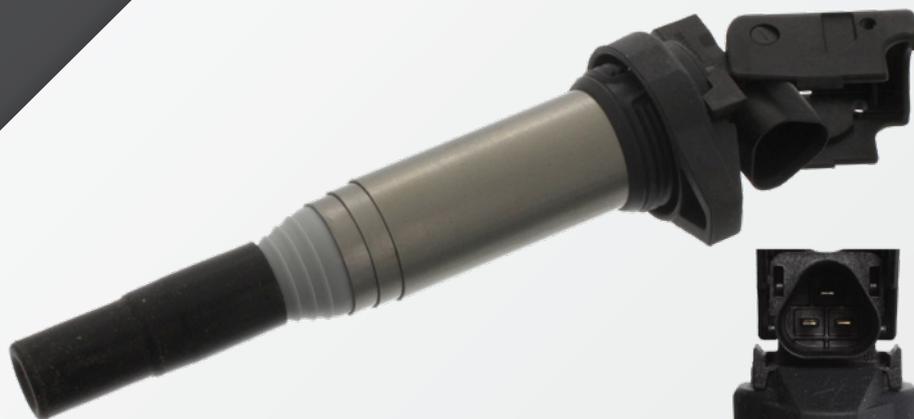
- The 'check engine' or 'service engine soon' indicator lamp is illuminated.
- Misfire fault codes stored in the engine control unit: 277F, 277E, 277D, 277B, 2771, 2782, 2781, 2779, 2777, 2776, 2775, 2773, 2772, 2783, 277A.
- Poor, intermittent engine performance.

The different materials used in the original ignition coil construction can deteriorate over time - leading to failure. This is due to the high temperature fluctuations during engine operation.

Using a suitable diagnostic tool, begin the diagnosis by reading the misfire counter in the engine control unit functions. This will likely indicate the faulty ignition coil.

It is advised that - since the remaining ignition coils have been subjected to the same operating conditions - it will be necessary to replace all four ignition coils to ensure the best customer-focused repair.

Should the misfire faults or the poor intermittent engine performance continue, carry out further diagnosis as recommended.
