### When replacing the large low-pressure stage, use the spacer ring from the old turbocharger

**Vehicle Manufacturer:** BMW

**Engine code:** N47 D20 D

**BTS reference:** T916574GR

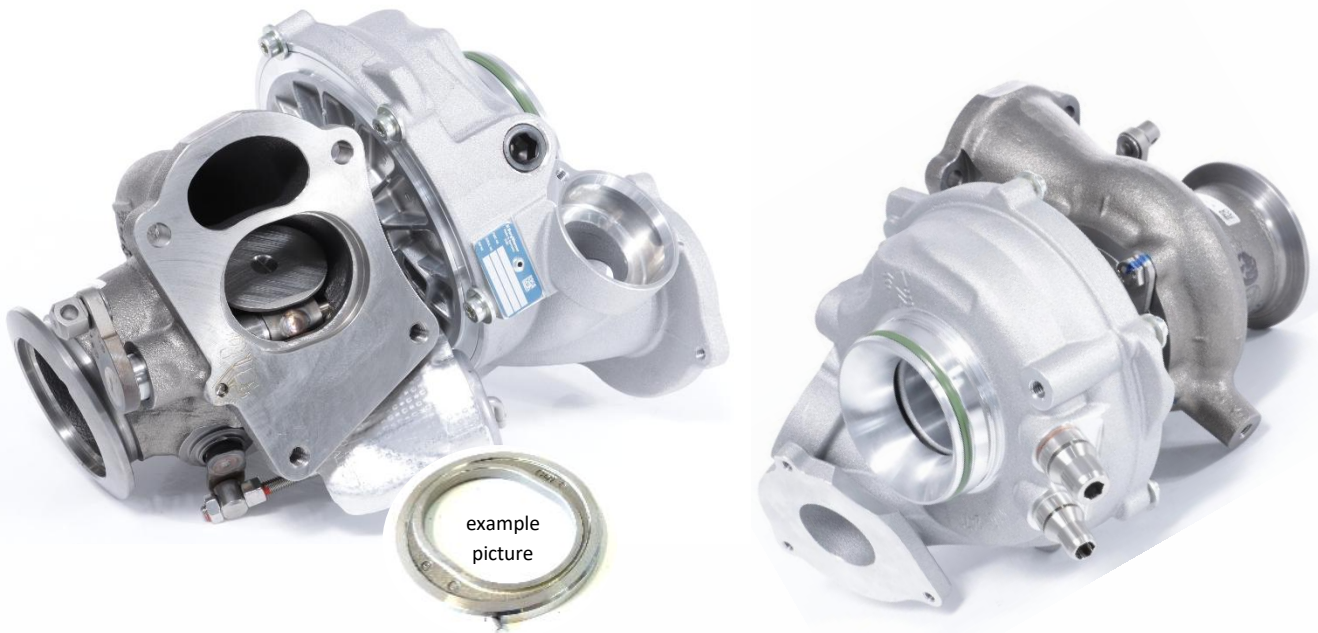
On the large low-pressure stage of the 2-stage turbocharger, a spacer ring is installed on the flange surface of the turbine housing to the exhaust manifold. This spacer ring has to be removed from the old turbocharger and inserted into the new charger.

The spacer ring must be checked for damage such as cracks and distortion. If in doubt, this spacer ring must be replaced. It must currently be obtained from the vehicle manufacturer, BMW 11 65 8 509 820. When installing the large low-pressure stage, make sure that the spacer ring is fully seated in the turbine housing and does not fall out during handling in the vehicle.

If the spacer ring is not installed, there will be a malfunction of the boost pressure control in the lower speed range, as the function of the exhaust gas throttle valve is not given.
