When replacing the large low-pressure stage, use the spacer ring from the old turbocharger

Vehicle: 535 d (E60, E61)

Engine code: N57 D30

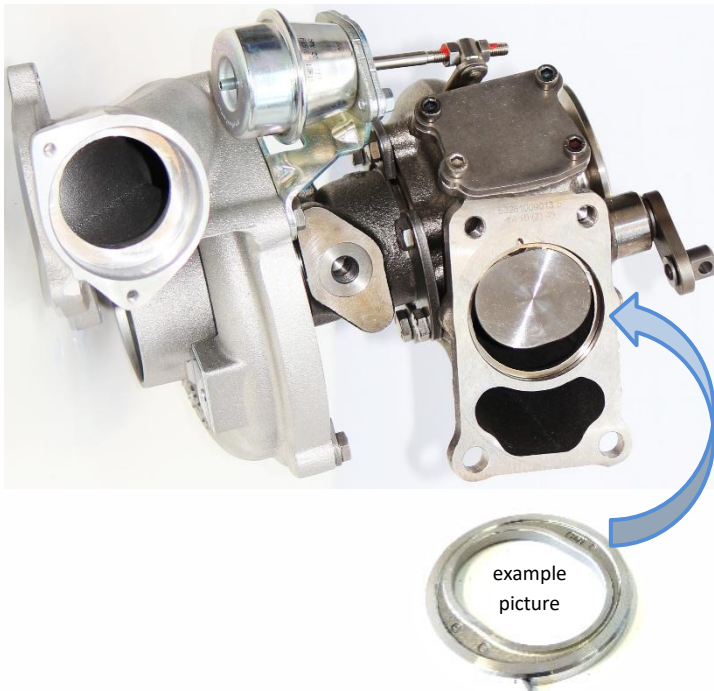
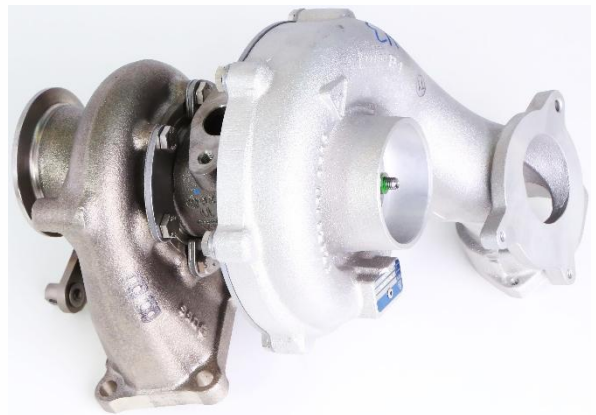
On the large low-pressure stage of the 2-stage turbocharger, a spacer ring is installed on the flange surface of the turbine housing to the exhaust manifold. This spacer ring has to be removed from the old turbocharger and inserted into the new charger.

If the spacer ring is not installed, there will be a malfunction of the boost pressure control in the lower speed range, as the function of the exhaust gas throttle valve is not given.

The spacer ring must be checked for damage such as cracks and distortion. If in doubt, this spacer ring must be replaced. It must currently be obtained from the vehicle manufacturer BMW 11 65 7 798 458. When installing the large low-pressure stage, make sure that the spacer ring is fully seated in the turbine housing and does not fall out during handling in the vehicle.
