# PRODUCT KNOWLEDGE

## PISTON DAMAGE – RECOGNISING AND RECTIFYING

### 2.4.5 RING LAND FRACTURES

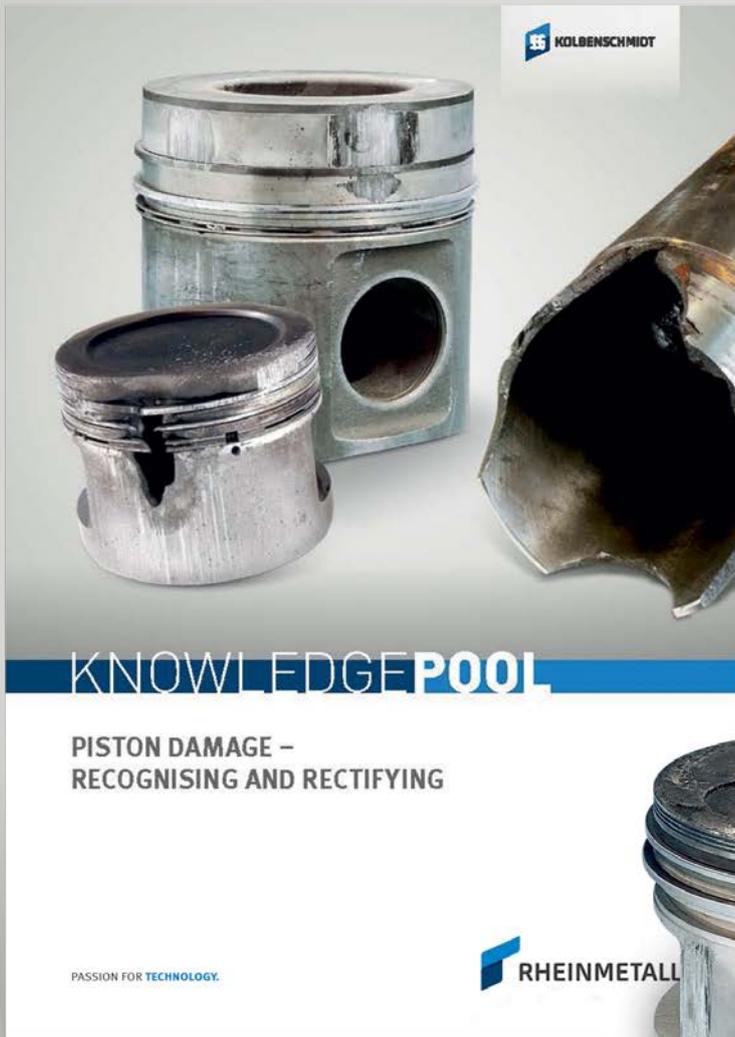
Fig. 1

- Ring land fracture on one side of the piston between the first and second compression ring (Fig. 1).
- Fracture, starting at the groove base at the top and running at a diagonal angle into the piston material, emerging at the groove base underneath (Fig. 2).
- Fracture is extended downwards.
- No piston seizure marks or signs of overheating.

Land fractures are not caused by material faults, but by material overload. A distinction can be made between 3 different causes:

Ring land fractures caused by knocking combustion usually occur on the pressure side. On a diesel engine, knocking combustion is caused by an ignition delay.

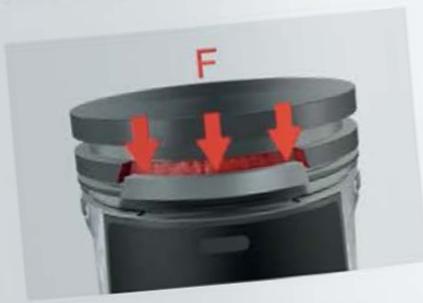
Fig. 3 shows the course of a fracture that occurs with knocking combustion and hydraulic locks: the force causing the fracture and acting from above on the ring land causes the fracture surfaces to extend downwards.

Liquid (water, coolant, oil or fuel) accidentally enters the combustion chamber when the engine is stopped or running. As the liquid is incompressible, the piston and crankshaft drive are subjected to enormous stresses during the compression cycle. This results in ring land fractures, boss fractures or connecting rod/crankshaft damage.

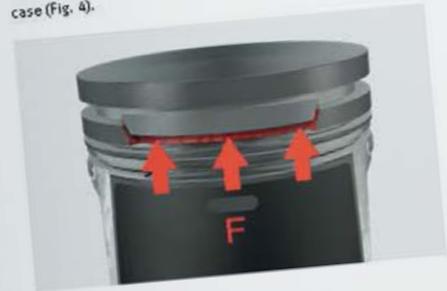
Fig. 4

If the piston rings are incorrectly compressed, more force is required when installing the piston. Forcibly pressing in or knocking in the piston causes pre-damage to the ring lands in the form of fine hairline cracks. The ring lands fracture in the reverse direction as the pressure comes from below in this case (Fig. 4).
