Blue Print ADT36846C

To fit:
 Renault Espace 2002>, Vel Satis 2006>
 Toyota Avensis 2.0 D-4D (CDT220) 1999>2003, Avensis Verso 2.0 D-4D (CLM20) 2001>2005, Corolla 2.0 D-4D (CDE110) 2000>2001, Corolla Verso 2.0 D-4D (CDE120) 2001>2004, Corolla 2.0 D-4D (CDE120) 2001>2007 (90bhp & 109bhp), Previa 2.0 D-4D (CLR30) 2001>2007, RAV4 2.0 D-4D (CLA20/21) 2001>2006, Landcruiser 90 3.0 D-4D 2000>2002, Landcruiser 120 3.0 D-4D 2002>2004

Renault / Toyota - Suction Control Valve Diagnosis and Replacement

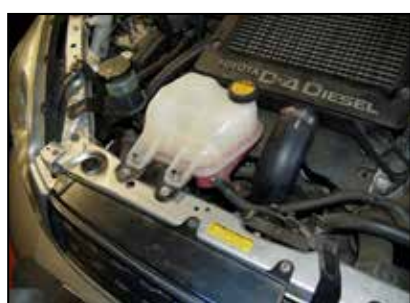
2003 Toyota RAV4 2.0D-4D engine compartment

- Unbolt the radiator expansion bottle (2 nuts) and move it to one side to gain access to the fuel pump. (You may wish to disconnect the upper hose and plug it to give you more room).
- Remove the air intake/intercooler pipe.

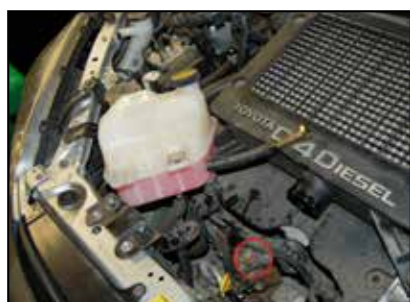
- The fuel pump is now visible (just to the left of the starter motor). Make sure the area around the green and red SCV's is as clean as possible to reduce the risk of debris entering the pump. **NOTE:** Debris entering the pump can cause injector malfunction leading to possible catastrophic engine failure.
- Disconnect the wiring connectors from the SCV's.

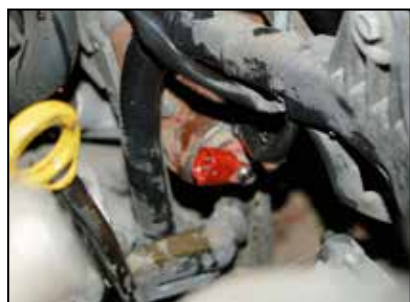
- Remove the four SCV mounting bolts (two per valve) and then remove the two valves from the pump making sure you note the positions of the red and green valves (red at the front).
- Although the seals on the new valves are pre-lubricated, it is good practice to apply a little engine oil to the seals to reduce the risk of damage during fitting.

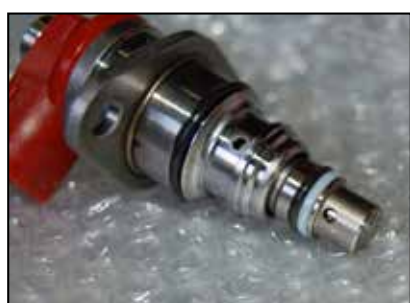
- Ensuring the mounting area is clean, install the valves carefully making sure that they are installed in their correct positions and that the valve flange fits flush to the pump before tightening the fixing bolts to 13Nm (10lb-ft).
- The rest of the fitting procedure is the reverse of the removal.
- Reset the engine diagnostic trouble codes using a suitable diagnostics tool (or by removing the ECU fuse for a couple of minutes) before road testing vehicle.
