Blue Print ADBP450228 ADBP450229

To fit: Mazda CX-5 equipped with electric parking brake

Brake Caliper with parking brake motor

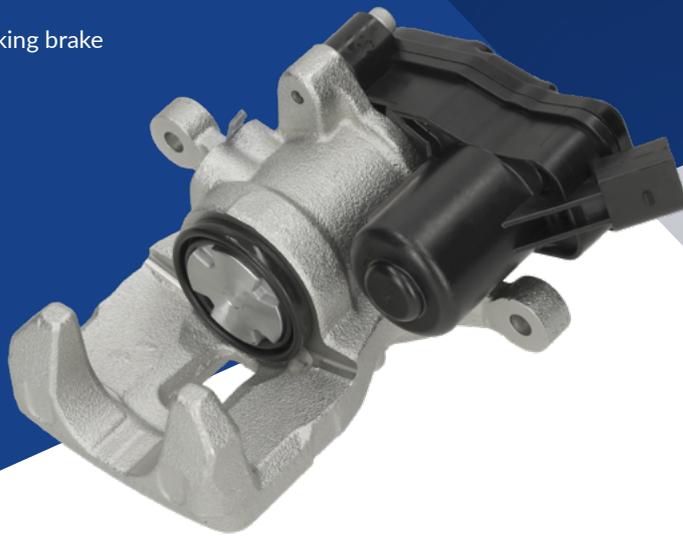
Vehicles equipped with an Electric Parking Brake (EPB) system may exhibit rear brake caliper drag, resulting in brake noise and accelerated or uneven wear of the outer brake pad. The vehicle may also momentarily roll to one side when starting from a standstill with the EPB applied. The EPB is failing to automatically release both wheels at the same time.

The symptoms described above are caused by the EPB not being completely released. The EPB control module determines that the parking brake is fully released when the motor current falls below the specified threshold as the spindle's rotating torque decreases. The spindle may momentarily spin freely during the EPB release process, this causes its rotating torque to drop to the threshold level before the parking brake is fully released.

Carry out the following steps to verify that the EPB is automatically released on both sides at the same time when starting the vehicle from a standstill with the EPB ON.

- Ensure the driver's door is closed and the driver's seat belt is fastened otherwise the automatic release function of the EPB may not work properly.
- Depress the brake pedal firmly, turn on the EPB switch and release the brake pedal.
- Start the vehicle, pull away slowly from a standstill and check if the vehicle is held and rolls to one side.
- If the vehicle rolls for more than 0.2 seconds, the caliper on the side that the vehicle rolls to requires replacement.
- If the vehicle does not roll, the EPB is automatically released correctly at this moment.
- Drive the vehicle at low speeds and check if the rear brake dragging noise is heard.
- If yes, the caliper on the side producing the noise is defective. NOTE: If it is difficult to detect which side the noise comes from, raise the vehicle and turn the wheels to verify that the brake disc rotates by hand when the EPB is off.

- Raise the vehicle and remove the rear wheels. Depress the brake pedal firmly and turn ON the EPB switch. Release the brake pedal. Depress the brake pedal and turn OFF the EPB. Then, verify that the brake disc rotates by hand.
- If the brake disc does not rotate then that caliper is defective.
- If both brake discs rotate easily, check the brake disc and pads for damage or discoloration caused by brake dragging.
- If one or more of the conditions specified are found, it indicates brake dragging and that the caliper on the affected side is defective.
- Replace the affected side with a new brake caliper as well as new brake discs and pads. Bleed the brake system and retest
