## TSB-349

## Transmission Noise/Groan

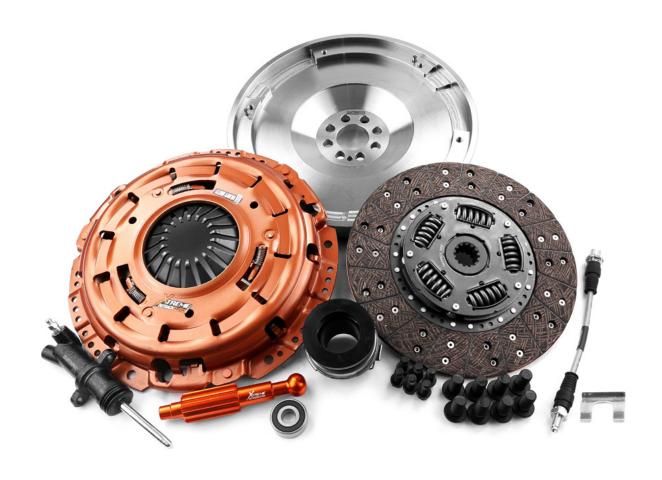
Please note that this is a Extra Heavy Duty Clutch and has a higher torque spring centre in the friction disc to accommodate for extremely high torque engines. As a result of this spring centre, additional transmission noise/groan may be present at lower RPM deceleration or idle crawl speeds. The extent of these harmonics may very depending on various other modifications to the vehicle and the configuration of the vehicle build.
