# CLUTCHTECH

## TSB-357

### Gearbox Installation

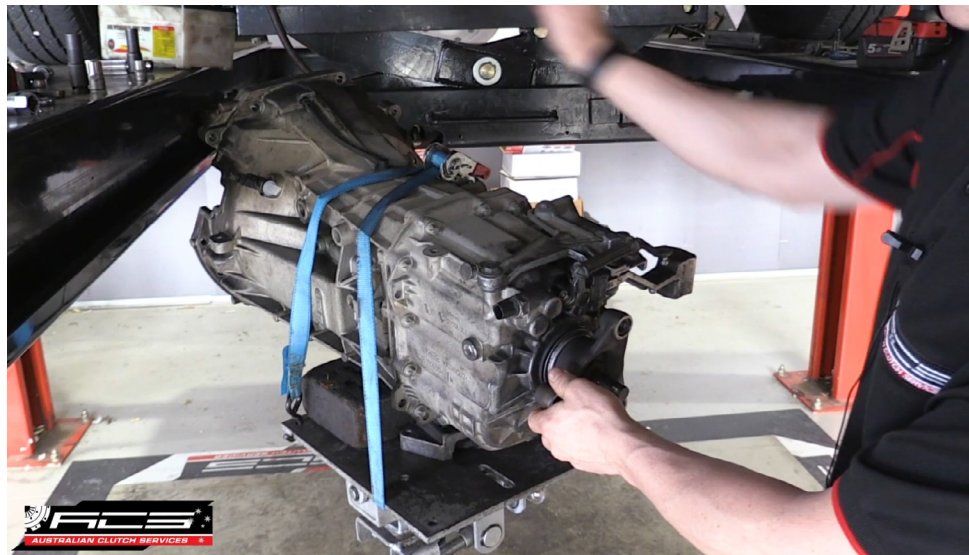
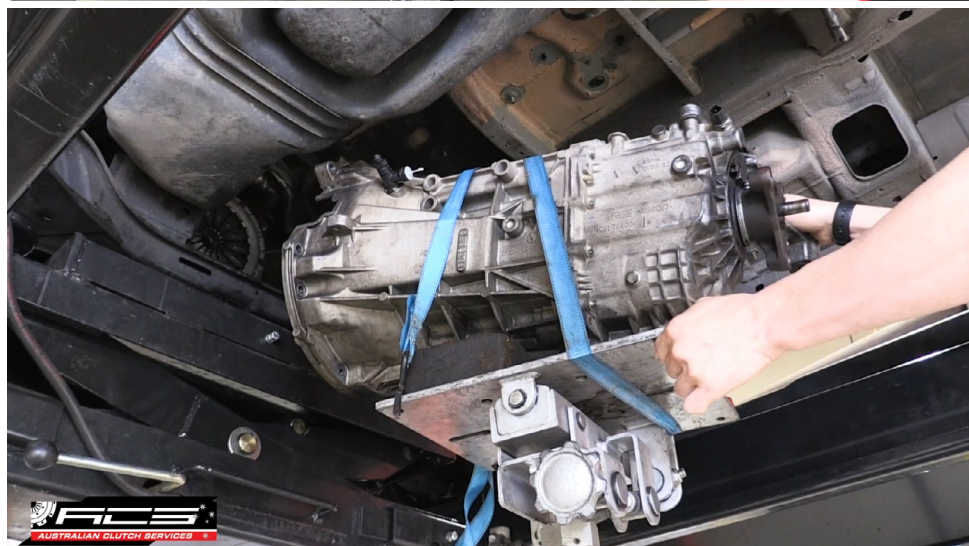
Due to the size and/or accessibility of the gearbox in this vehicle, it is common for the clutch disc to be damaged during re-installation of the gearbox.

Care must be taken to not lever or hang the gearbox on the clutch disc as this can bend the disc and cause difficulties in releasing the clutch during vehicle operation.

Always use an appropriate transmission/gearbox jack and support the full weight of the gearbox until at least 2 of the bellhousing bolts have been fastened.
