BEFORE YOU START INSTALLING THE EGR MODULE, ENSURE THAT ALL INSTRUCTIONS AND RECOMMENDATIONS BELOW ARE FOLLOWED.

To ensure the correct operation of the cooling system of MAN TGX Euro 6, it is necessary to calibrate the throttle manually with an actuator.

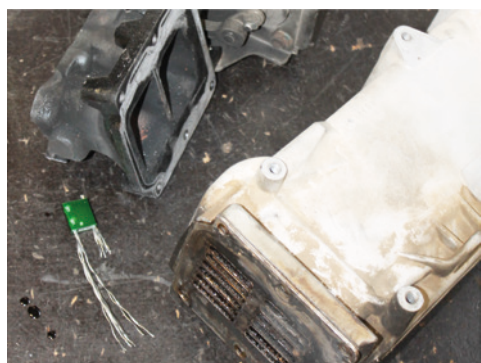
Loose or missing screws

Indicates unauthorized tampering with the part. Loose screws can lead to coolant leakage.
