Bulletin Ref: TB23a

Renault Broken Wire

AAL1163

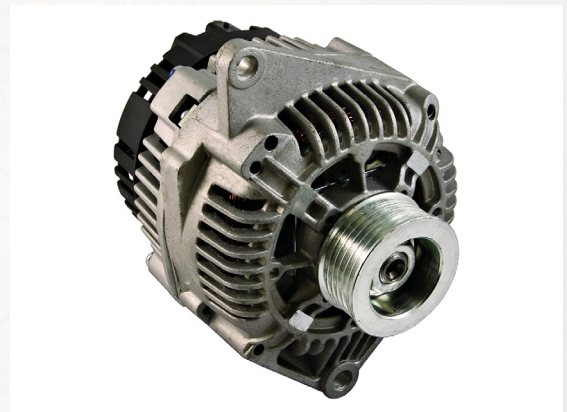
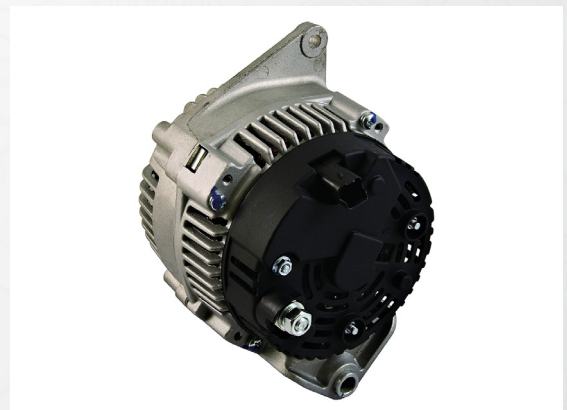
Poor or broken connections are common on these Renault models.

Trace the main feed from the plug to the wiring loom and check for broken wires or connections.
