CLUTCH TECHNICAL GUIDE

TBC61

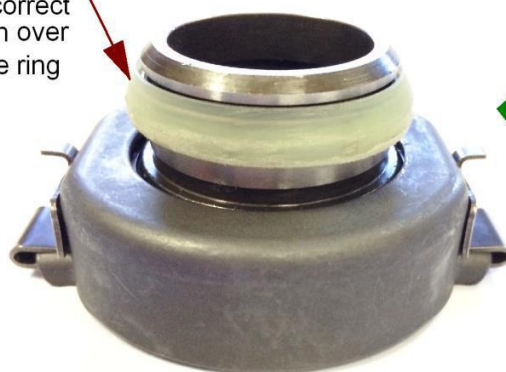
Plastic Sleeve
in the correct
position over
the wire ring

The bearing must have the plastic sleeve over the wire ring to enable the bearing to clip into the diaphragm retaining housing, and to ensure it engages correctly and holds securely.

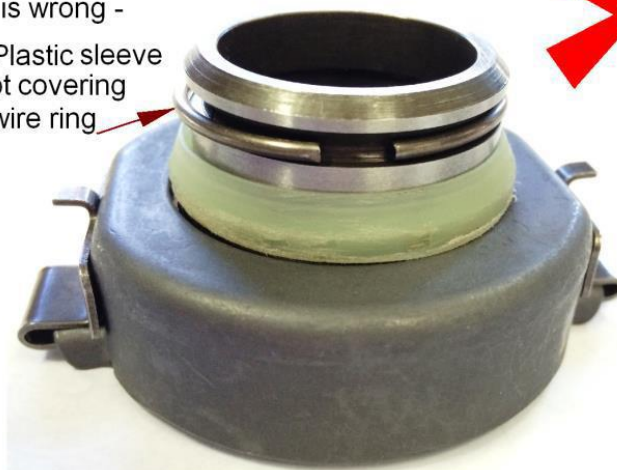
This is wrong -
the Plastic sleeve
is not covering
the wire ring
