NAL1598 - Renault Broken Wire

Bulletin Ref: TB23n

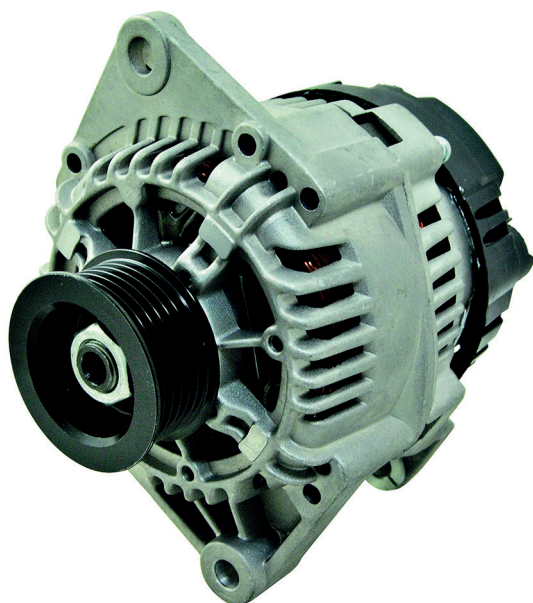
Poor or broken connections are common on these Renault models.
Trace the main feed from the plug to the wiring loom and check for broken wires or connections.
